Lessard-Sams Outdoor Heritage Council

Laws of Minnesota 2014 Accomplishment Plan

Program or Project Title: Restoration Evaluations

Technical Panel Findings and Recommendations—Fiscal Year 2015

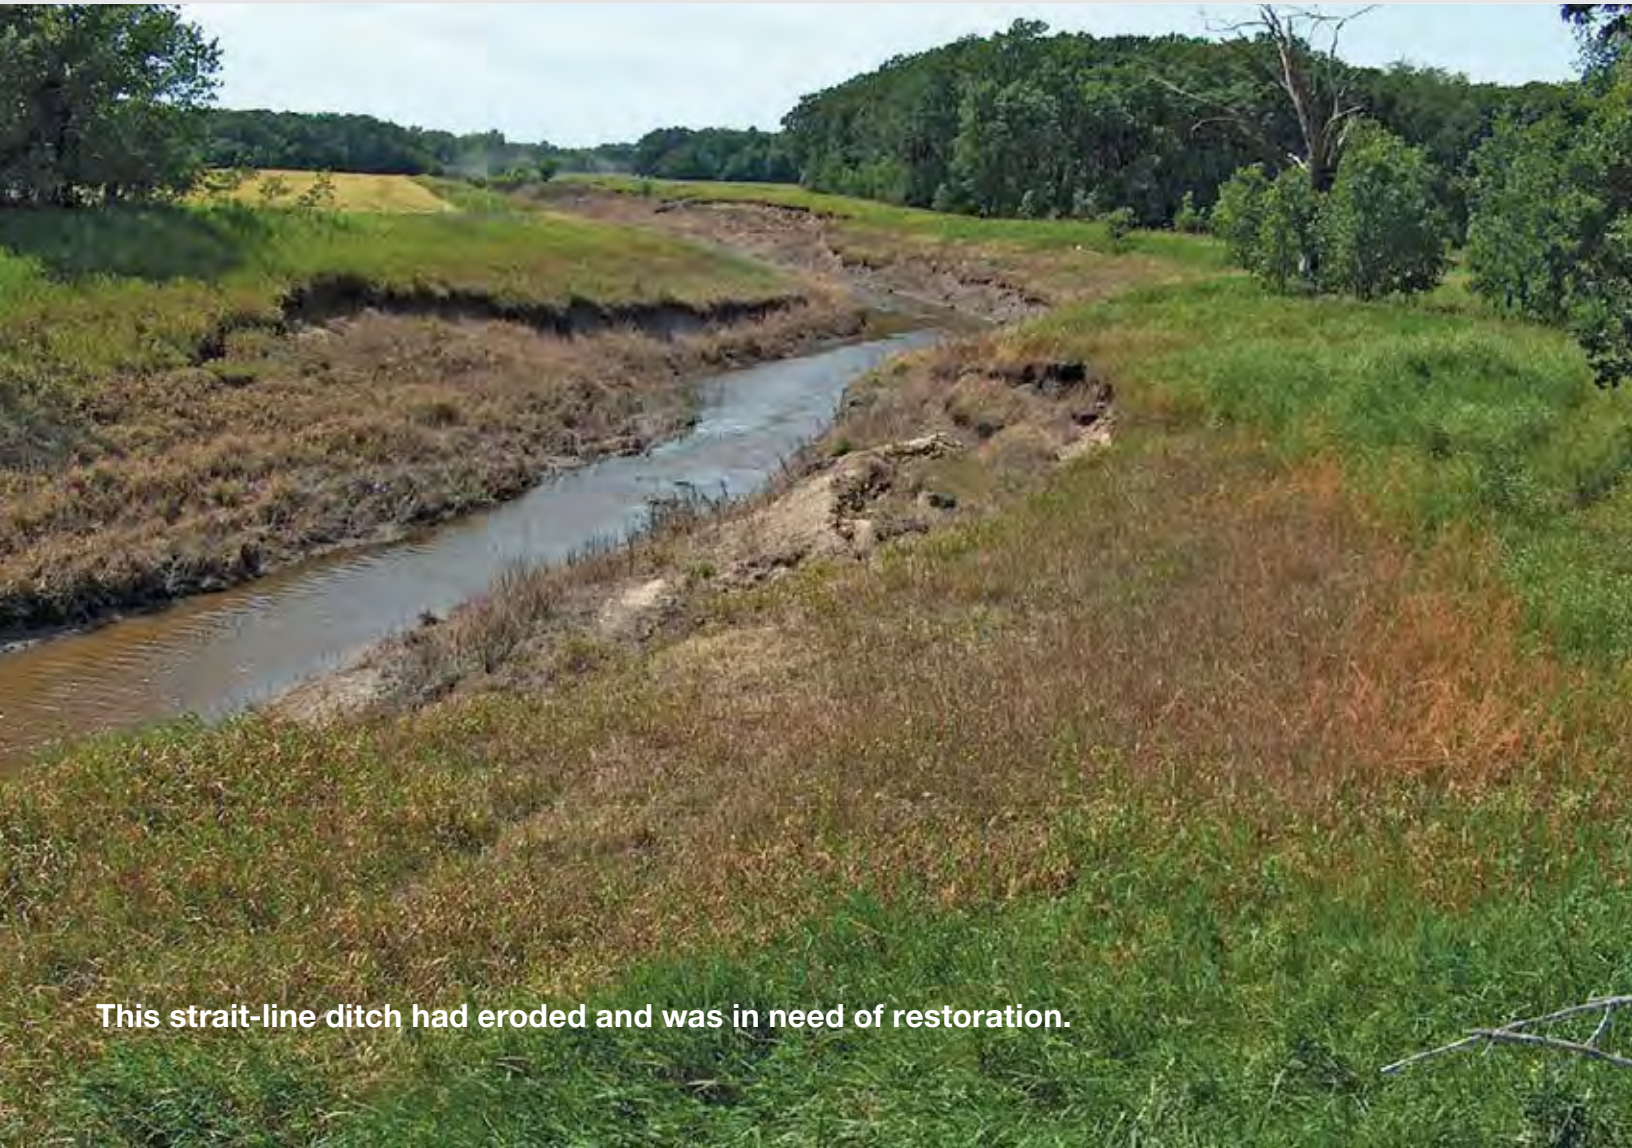
This strait-line ditch had eroded and was in need of restoration.

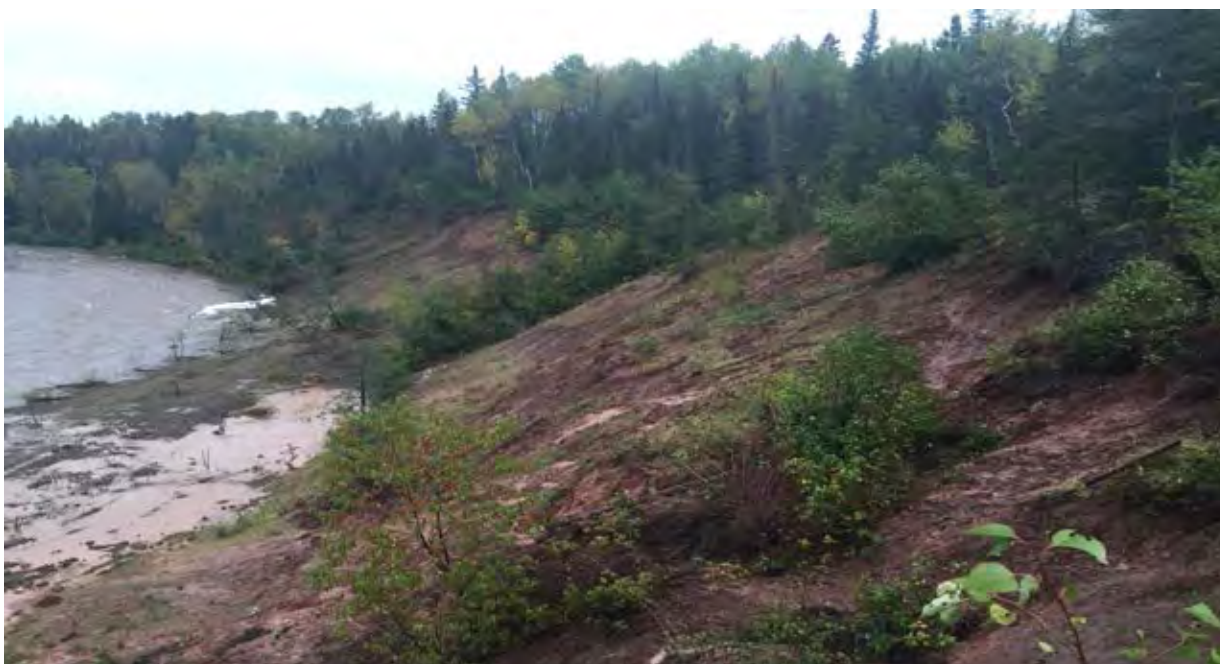
Figure 6 - Representative image of stabilization (bluff). As visible in photograph the attempt to establish vegetated cover on the clay bluff in question (right side of image) via hydroseeding is showing early signs of failure. It is acknowledged though that the primary project means for reducing sediment from the bluff is the realignment of the stream away from the bluff and the creation of a stable bluff toe and associated bankfull bench.

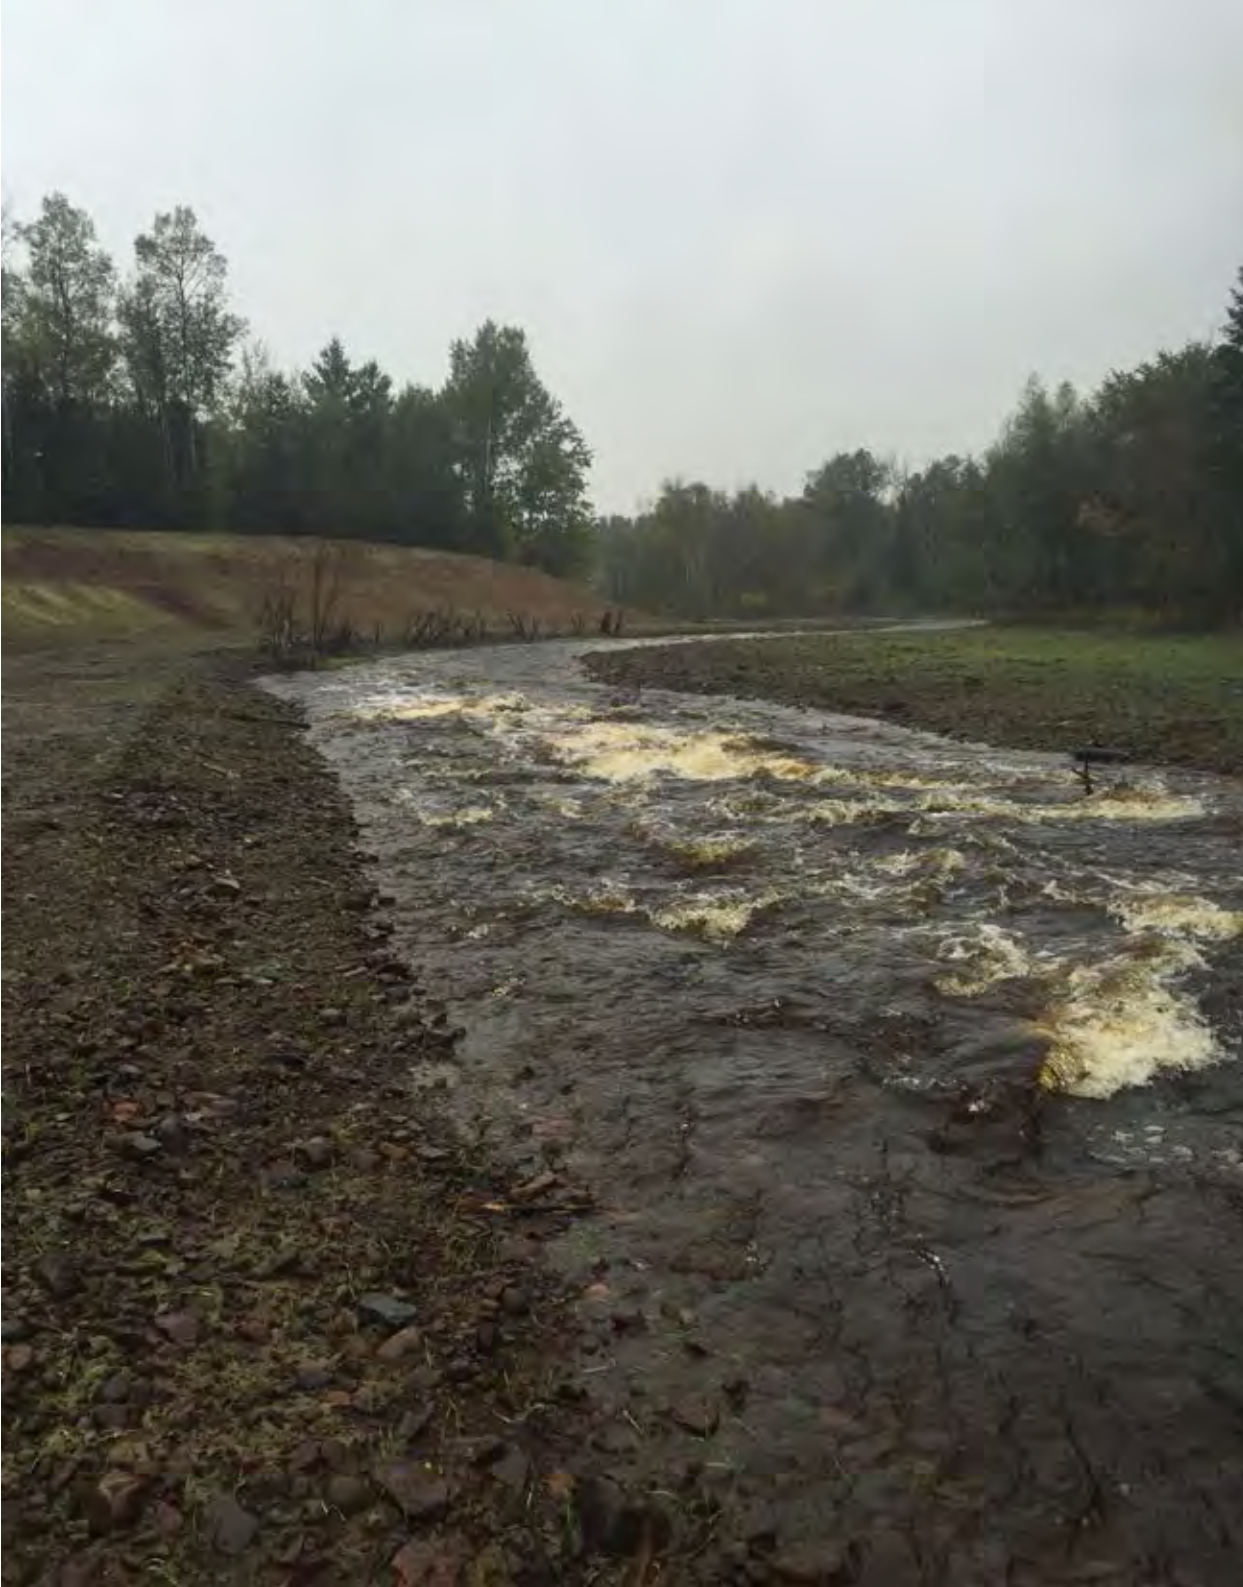
Figure 3 - Representative image of restoration. Stream was near bankfull discharge during site evaluation.

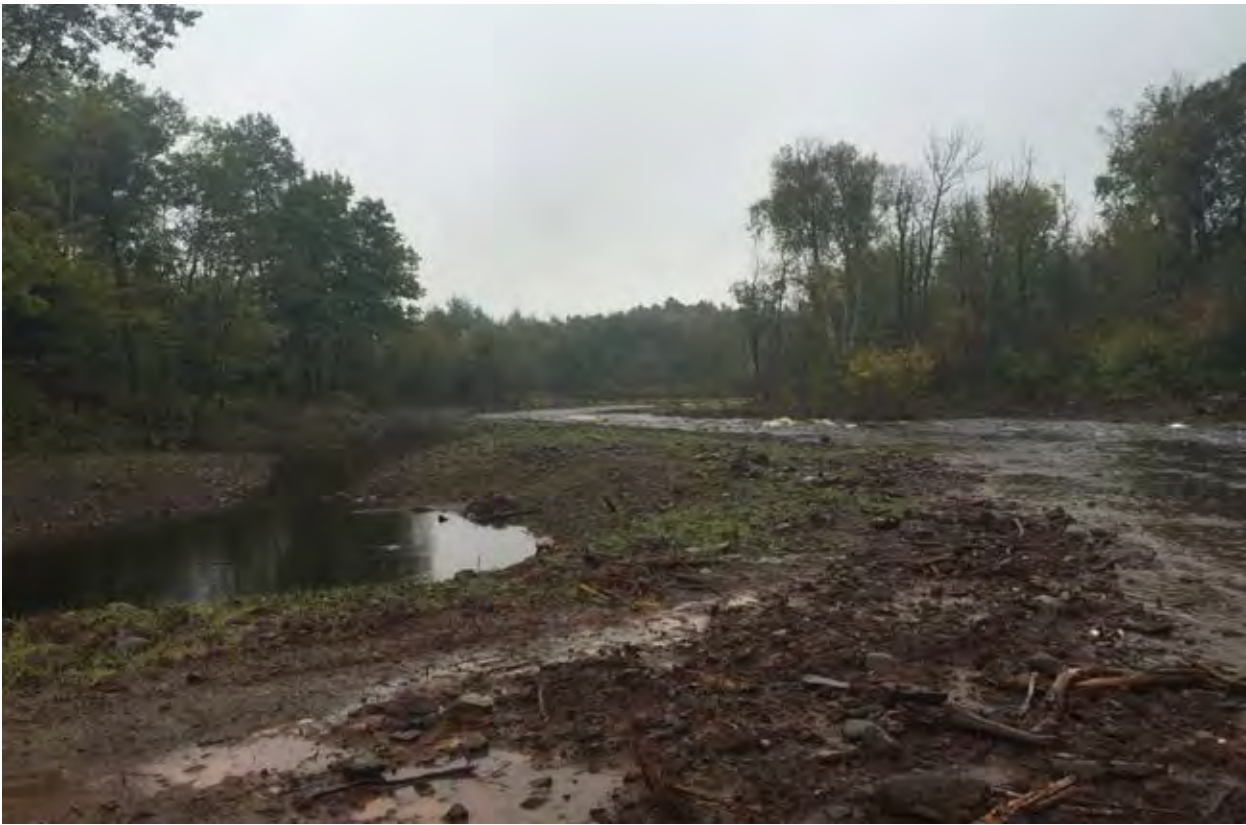
Figure 4 - Representative image of one of the created ponds (left).

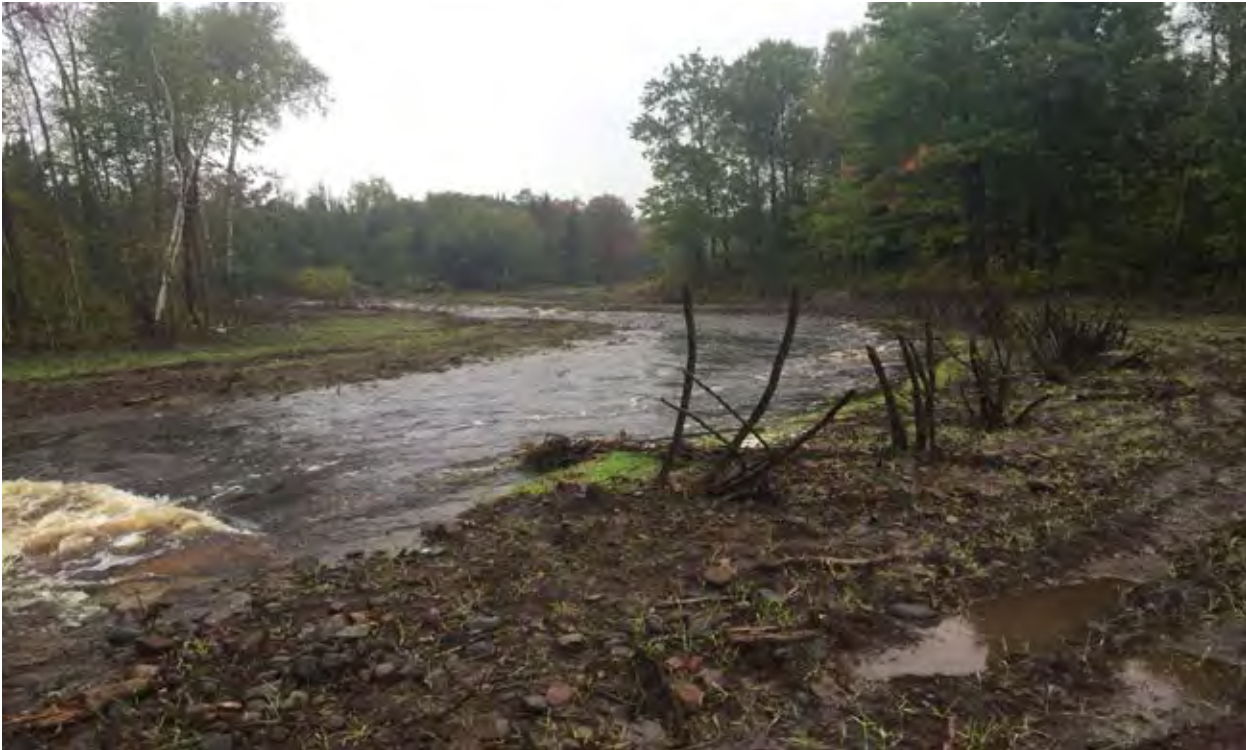
Figure 5 - Representative image of project elements: Toe Wood (right) with willow harvested mats above and Log J Hook with Rootwad downstream (left).

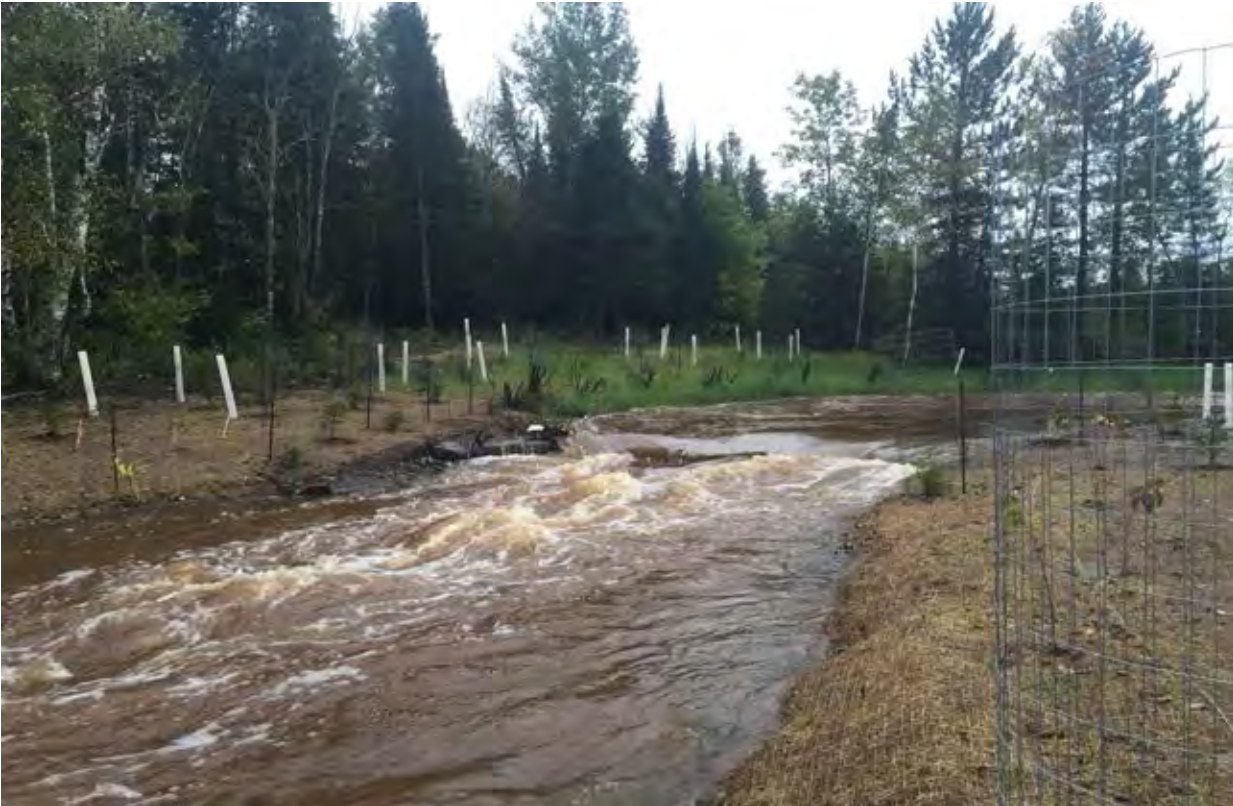
Figure 3 - Representative image of stabilization. Note the grade control structure (center images) was a project add-on (understood to have been requested and/or funded separately by Minnesota Trout Unlimited).

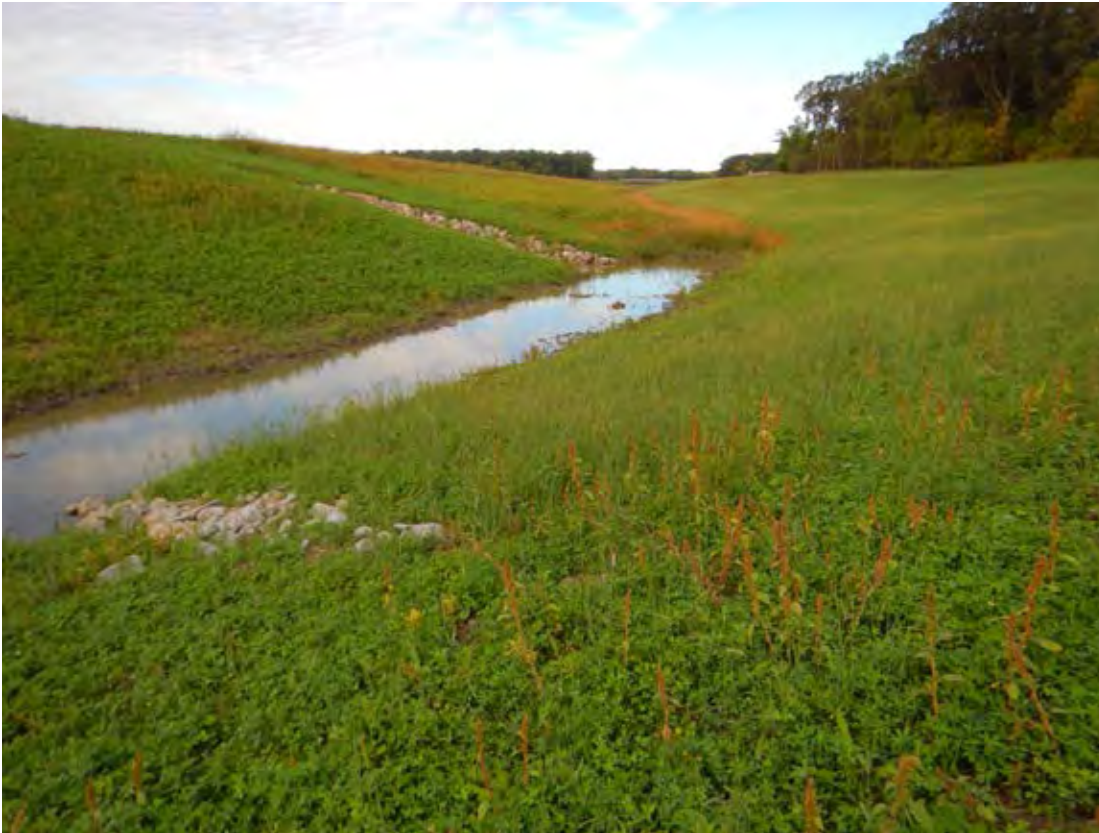
CC Photo 1: Stabilized slopes immediately south of Diversion Structure.

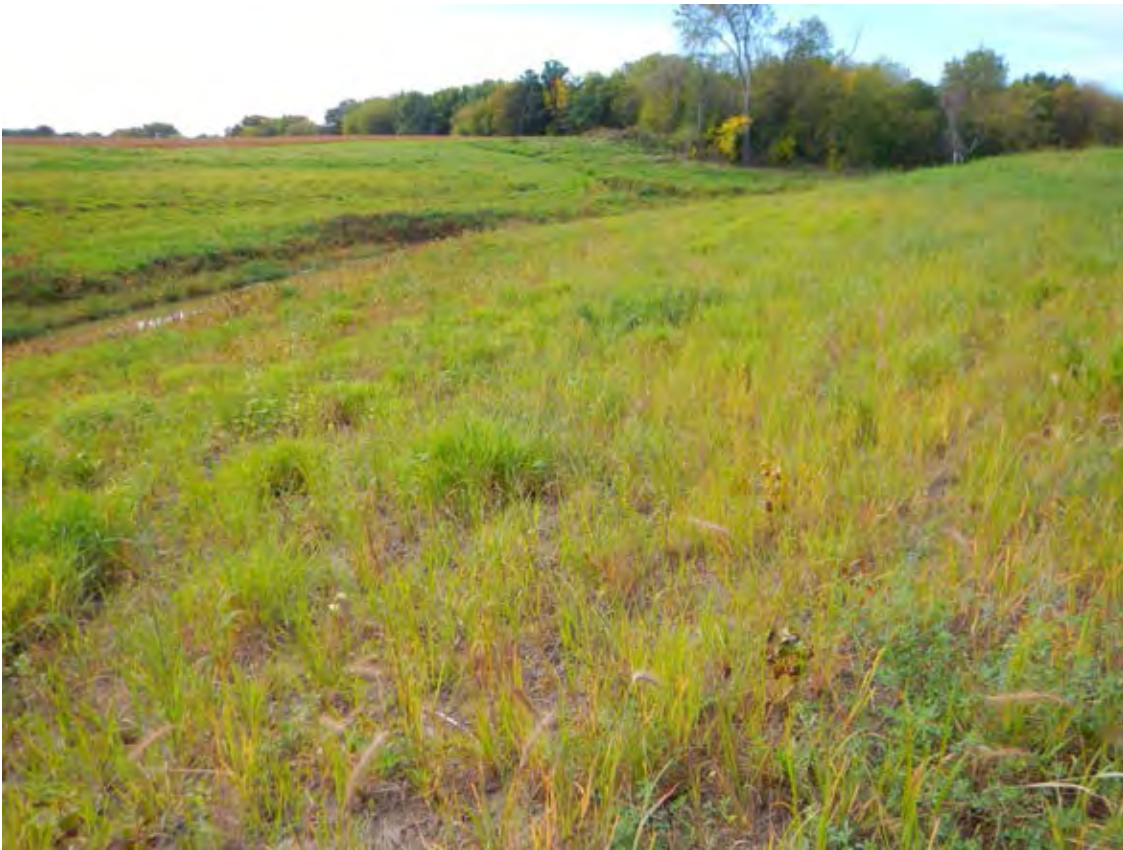
CC Photo 6: Slope in CRP planted upland above Upper Grade Control Structure.

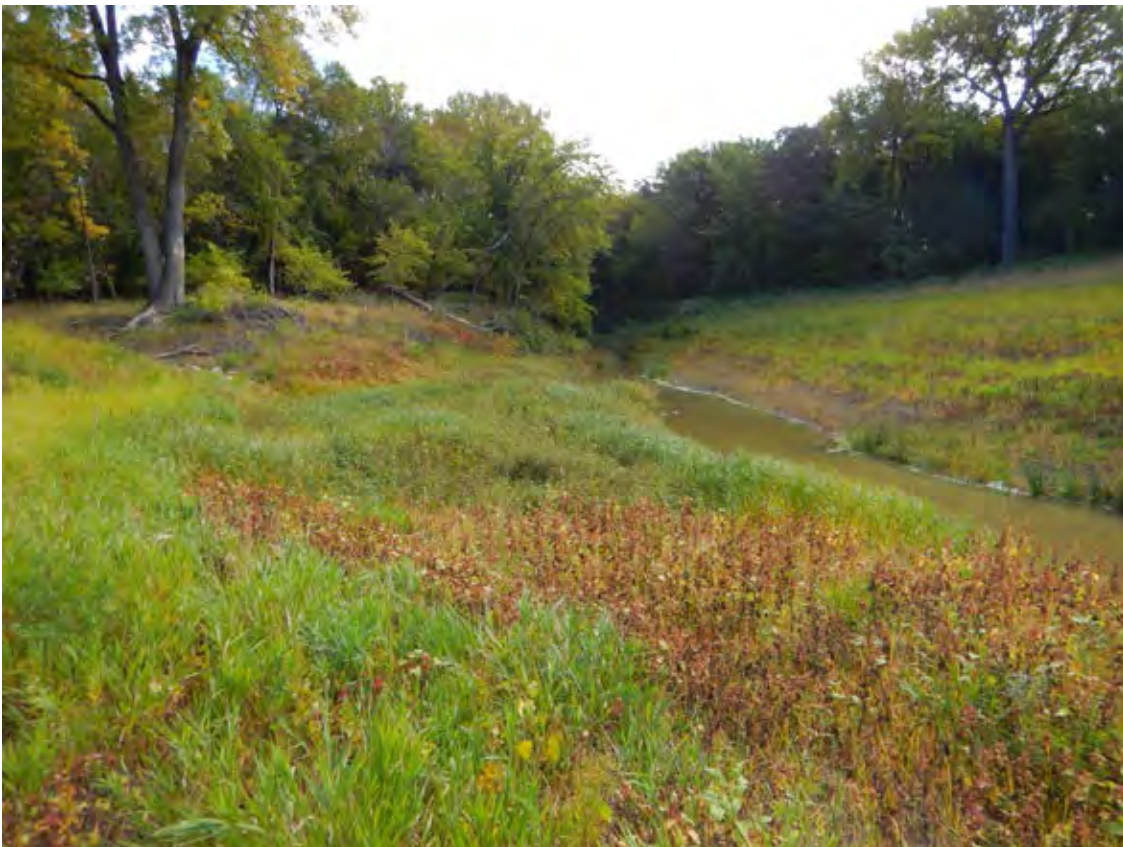
CC Photo 7: Wetland vegetation developing along channel above lower grade control structure.

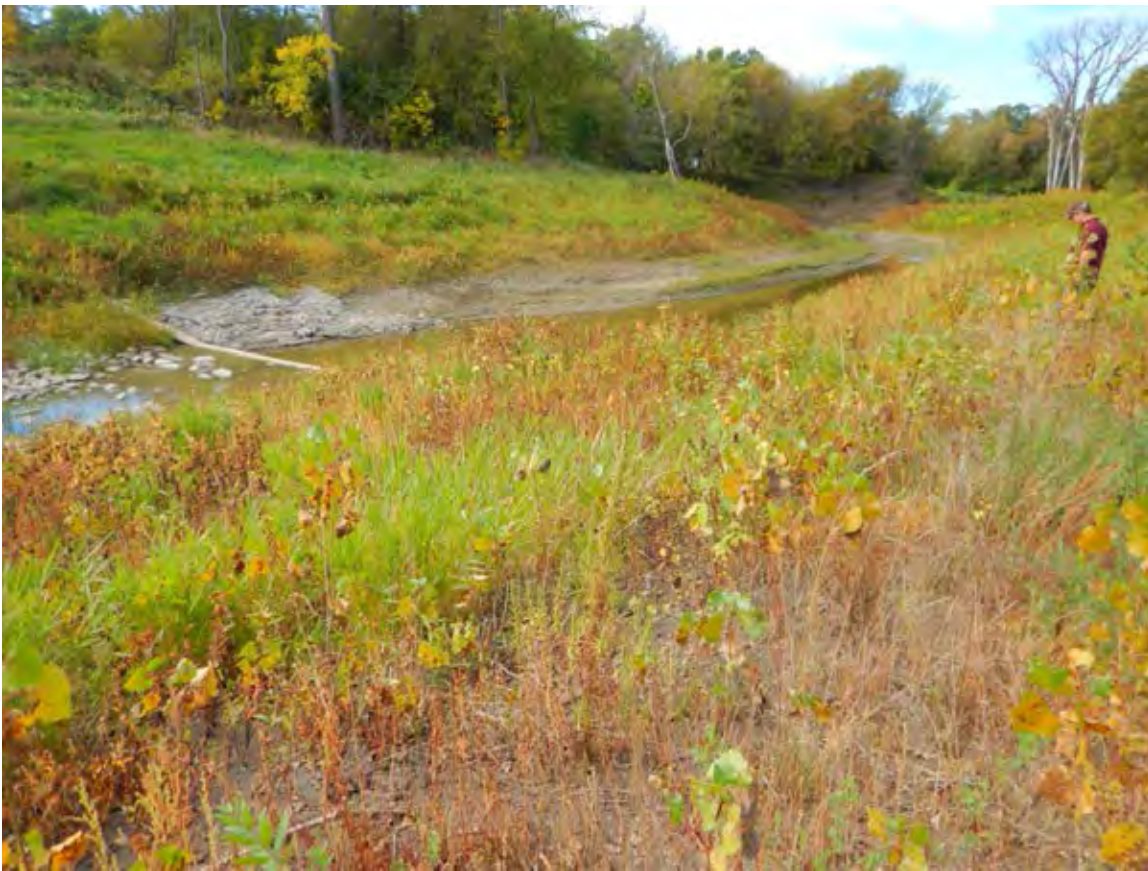
CC Photo 8: Lower grade control structure with upland grassland.

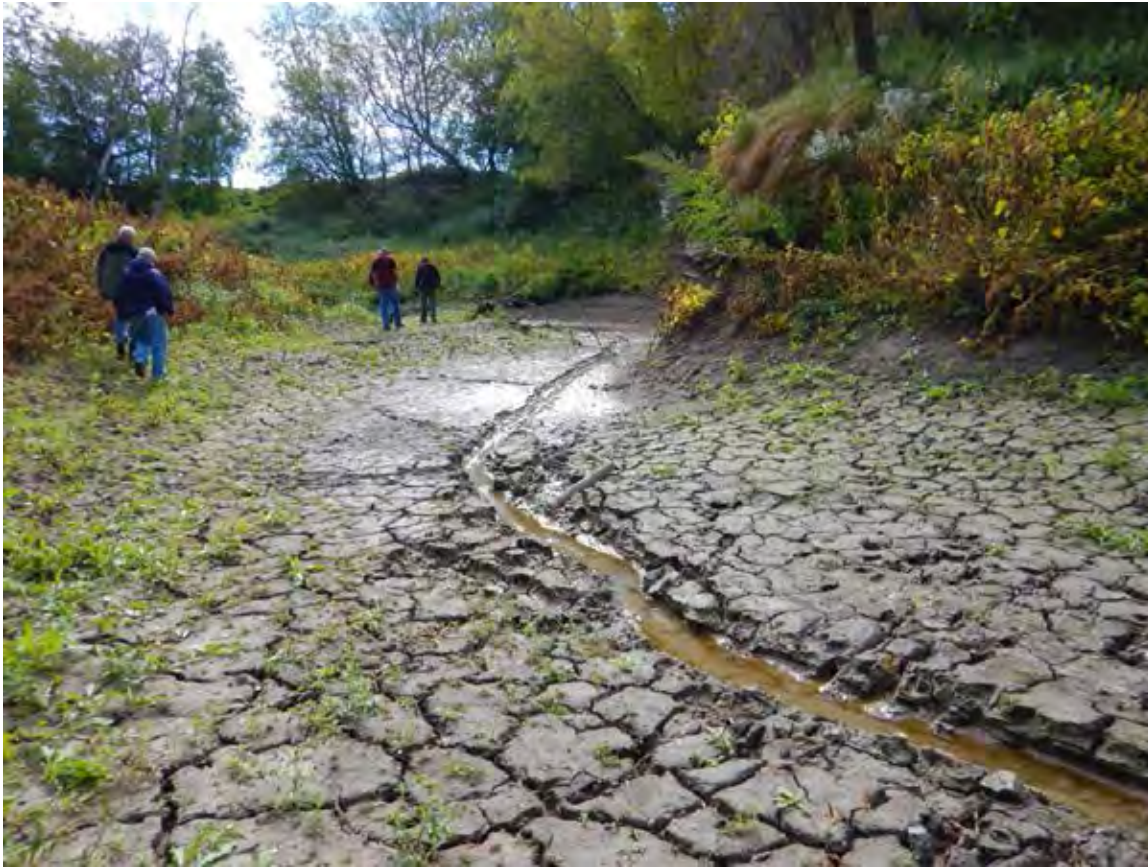
CC Photo 9: Mudflat near the confluence of Cut Channel and Red River.

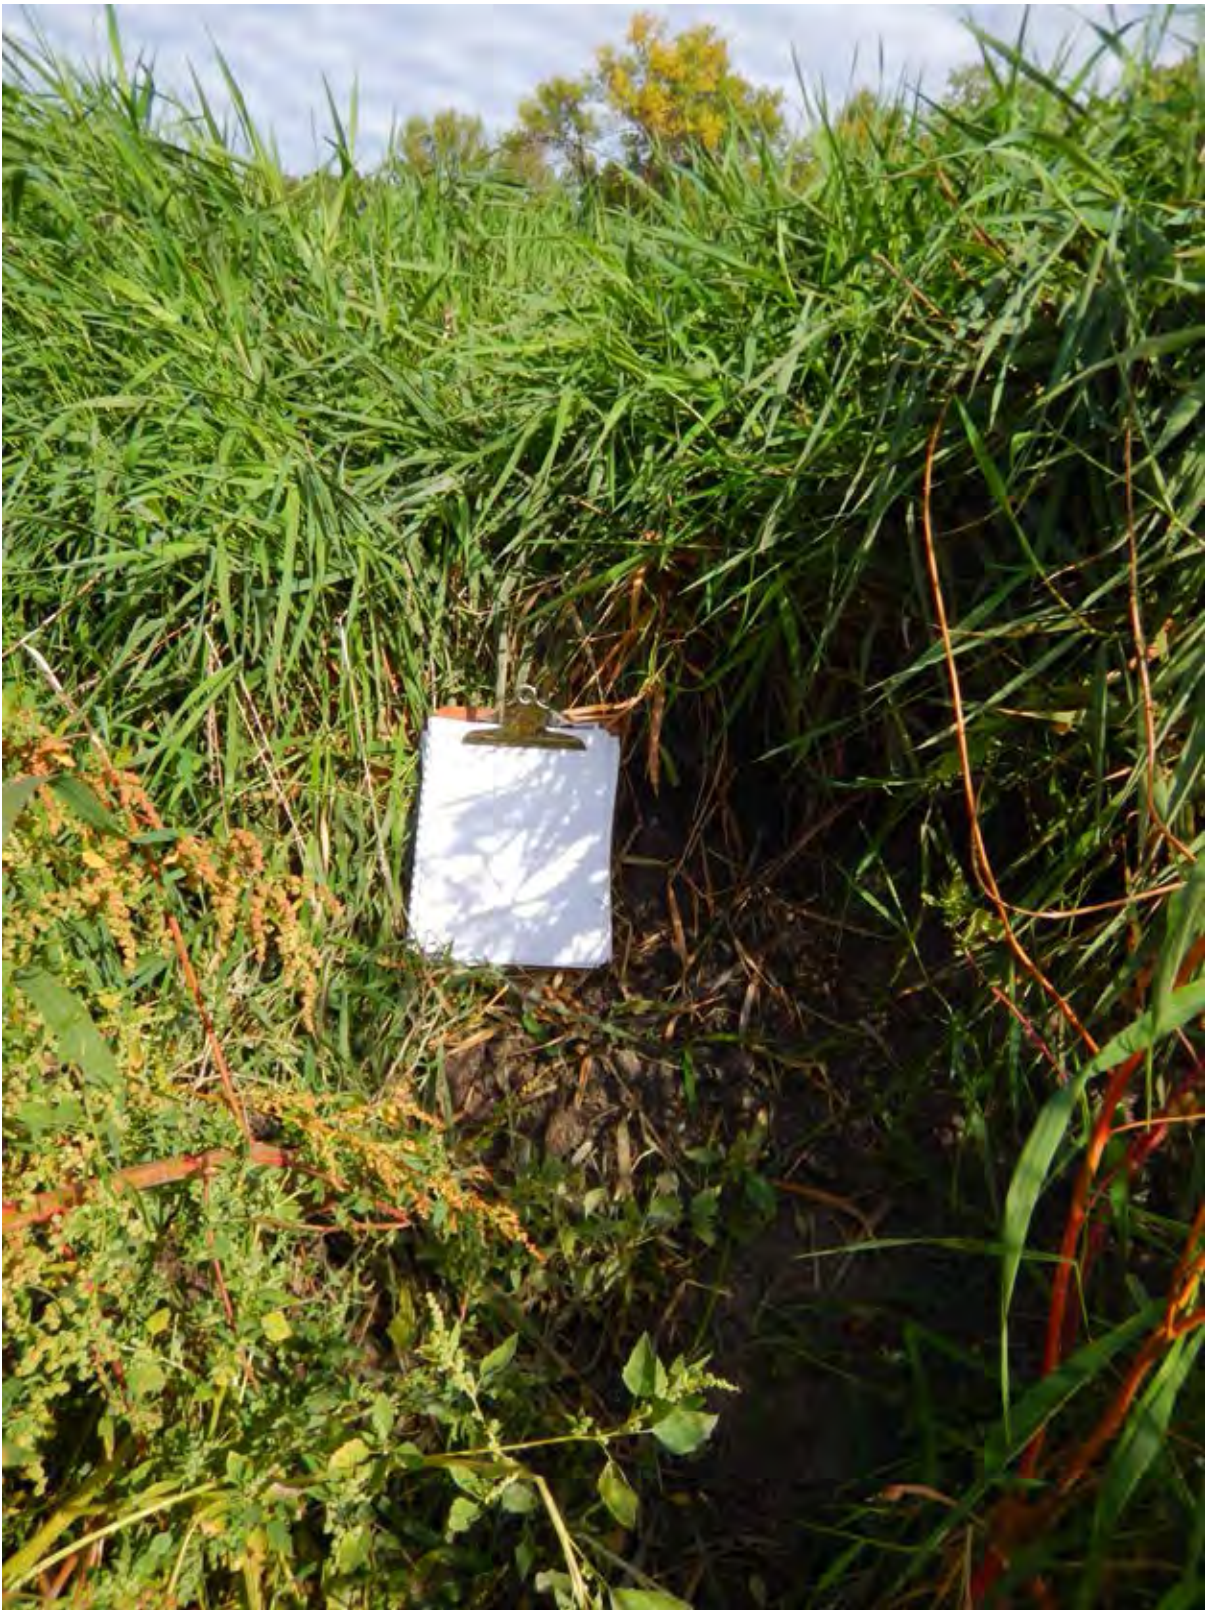
SR Photo 3: Area beneath vegetated bank dominated by reed canary grass.

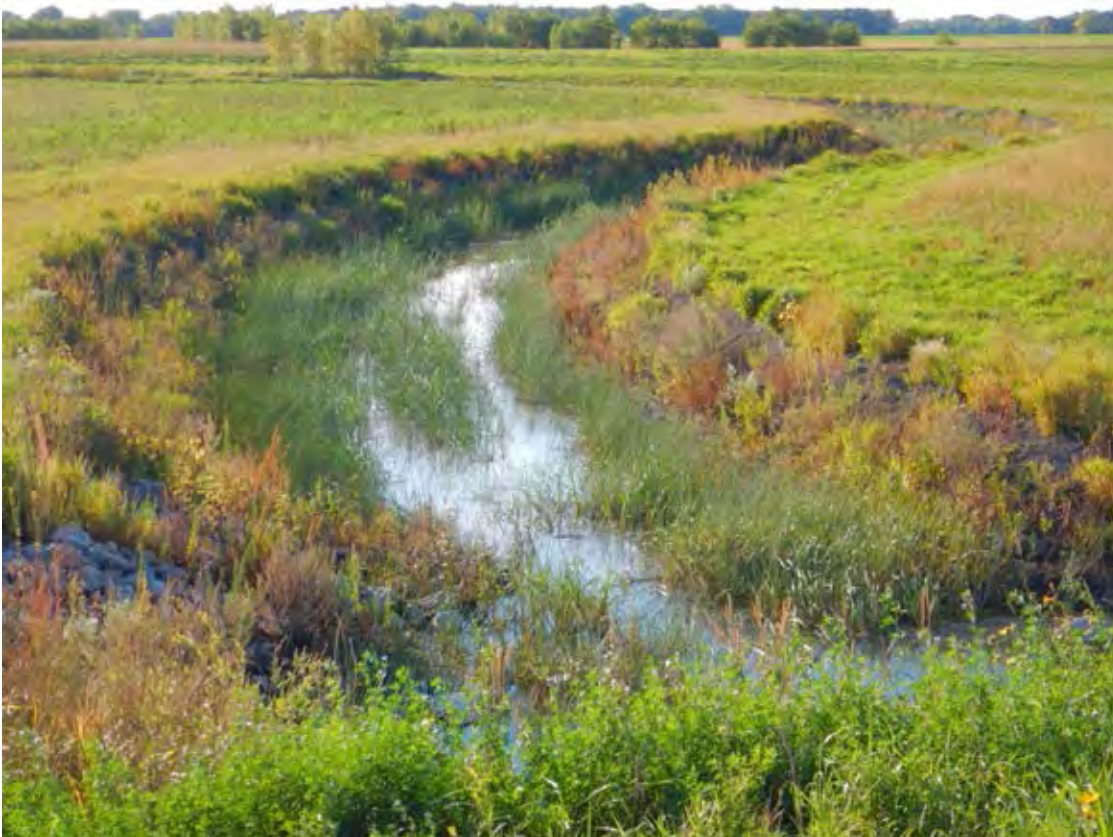
SR Photo 9: Constructed channel looking west from 470th Avenue NW. Channel dominated by Softstem Bulrush.

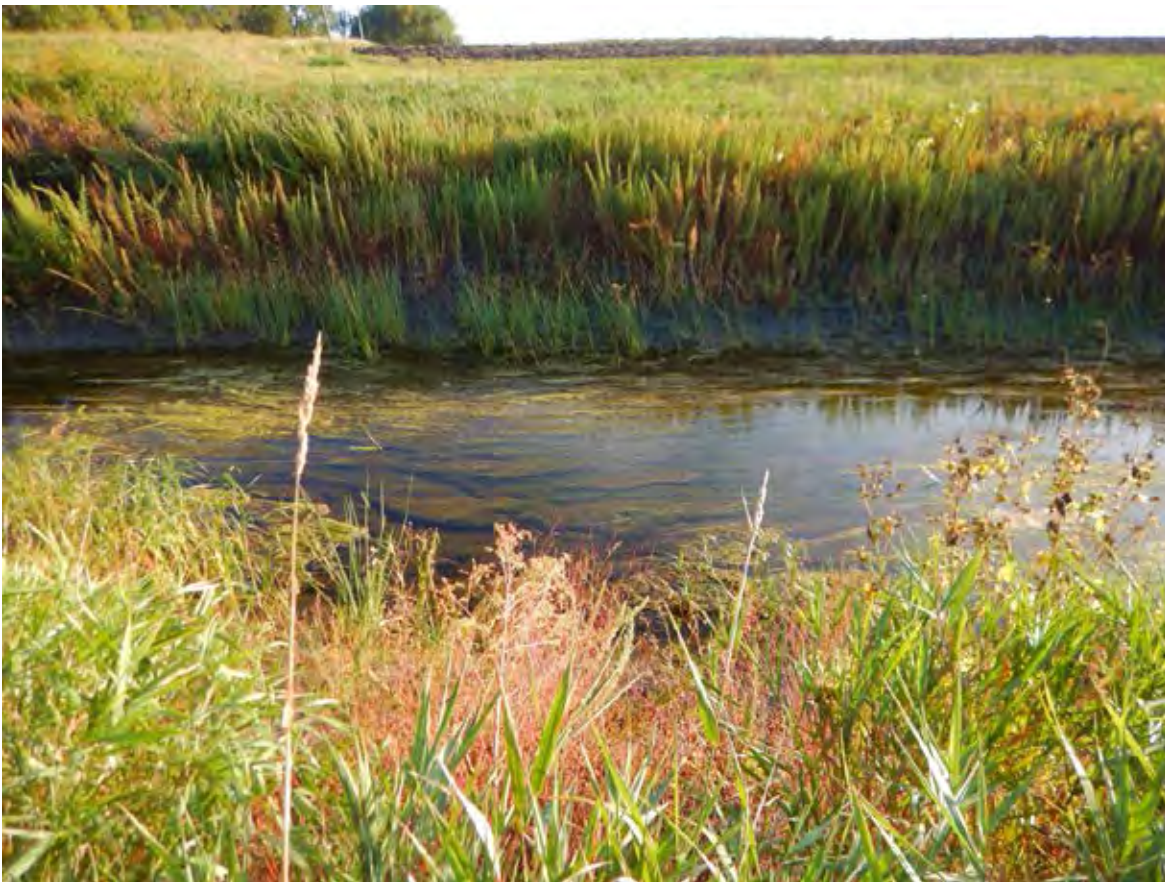
SR Photo 14: Unseeded slopes revegetating with predominantly annual weedy species.

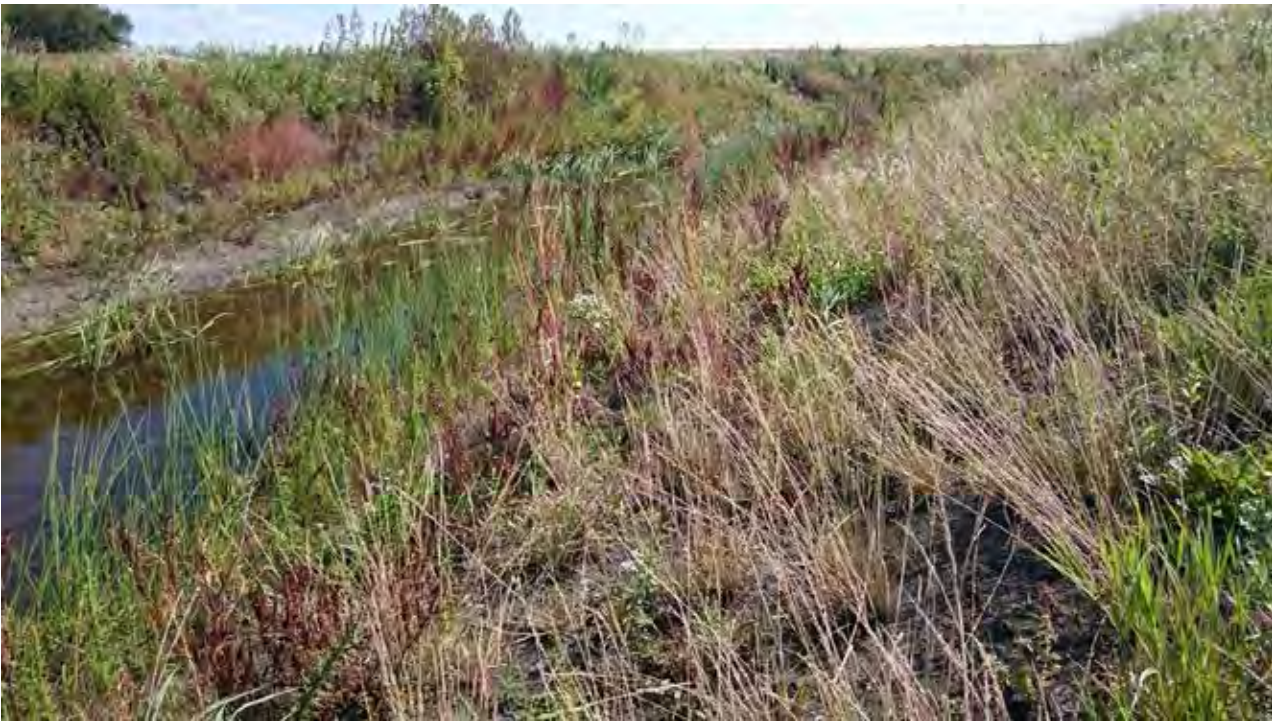
SR Photo 16: American Sloughgrass *Bechmannia syzigachne* dominates the lower unseeded slope in this location.

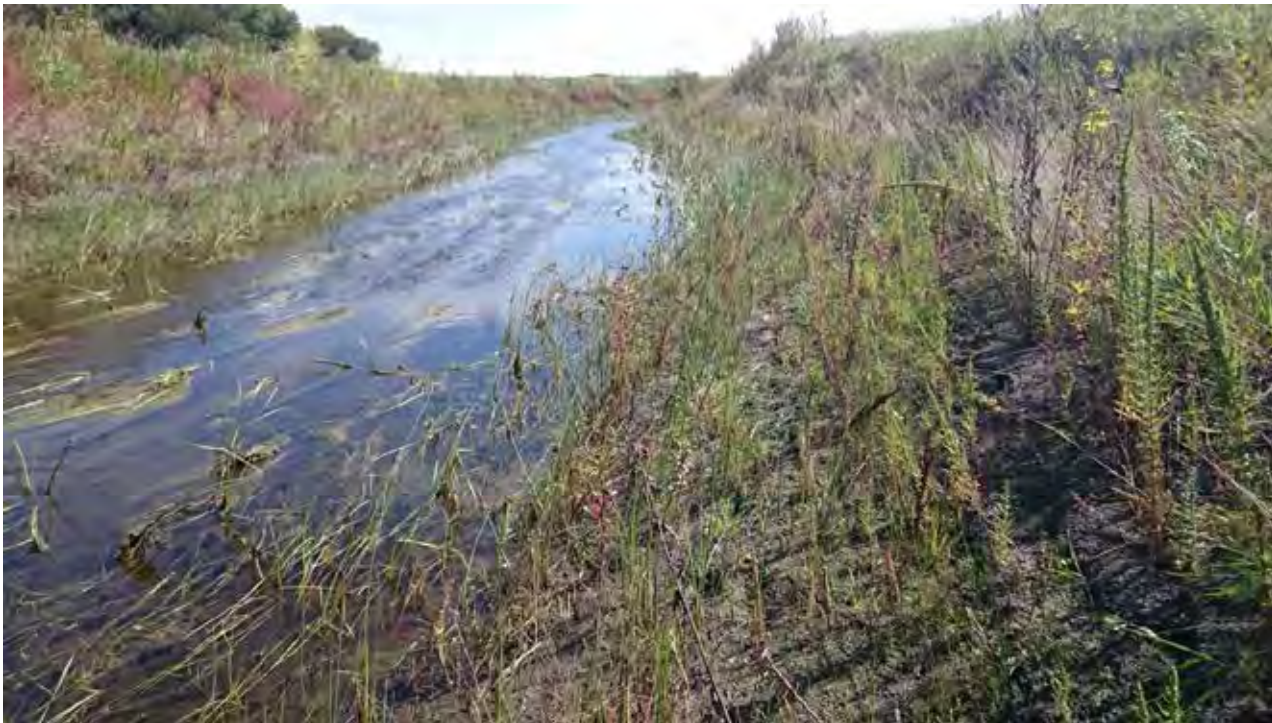
SR Photo 17: Softstem Bulrush in channel and saturated zone. Mostly annual weedy species inhabit the zone above.

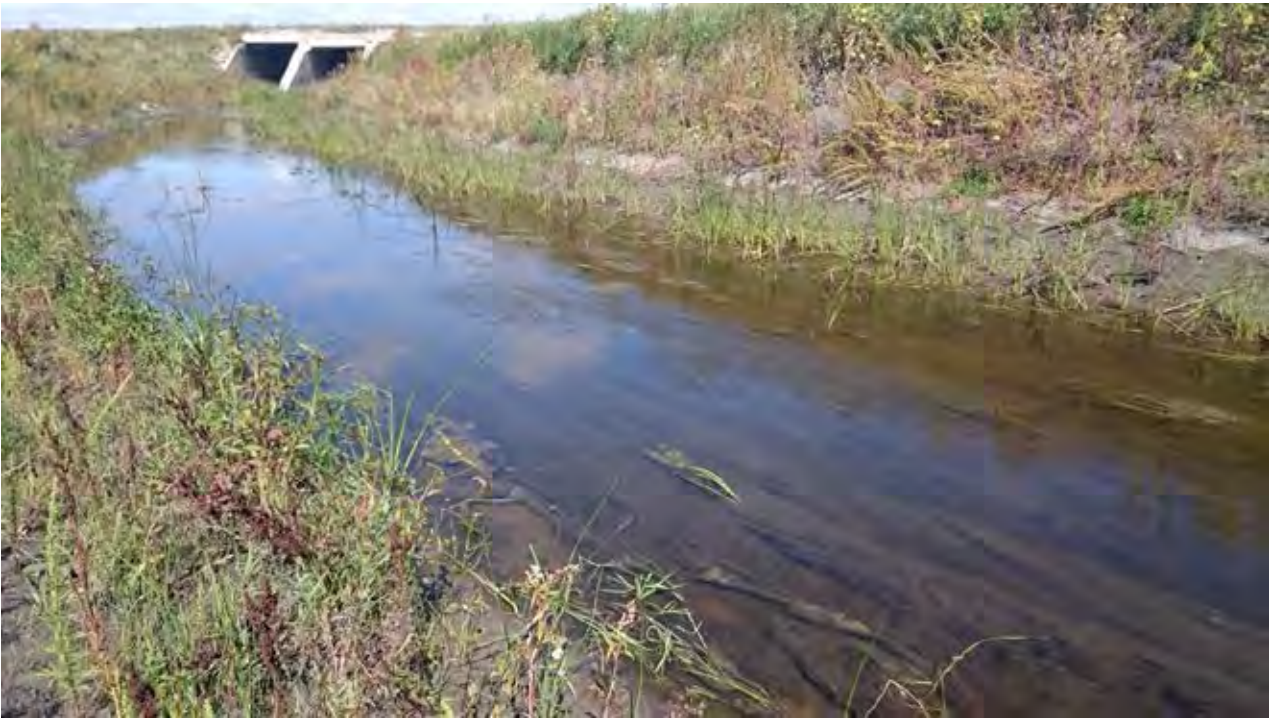
SR Photo 18: Stream channel upstream of the road crossing at 130th St. NW.

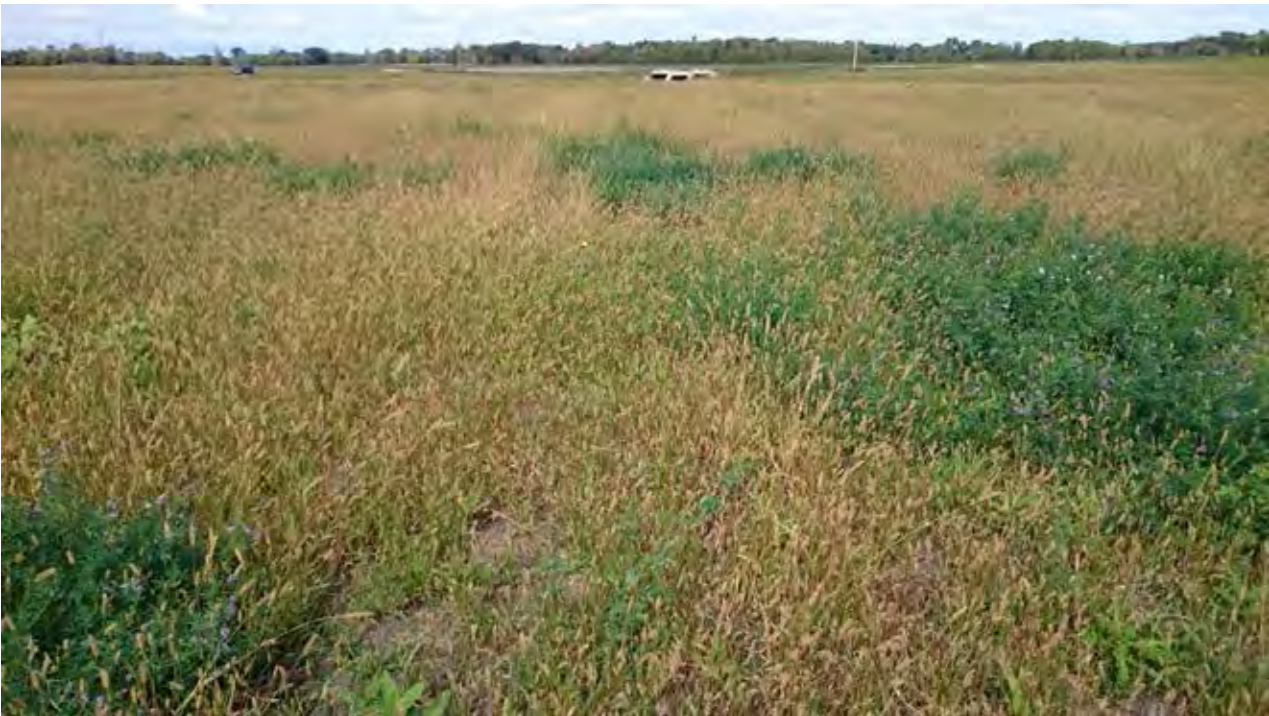
SR Photo 19: Upland area south of 130th St. NW. Appears to be seeded to CP-23A, similar to adjacent areas seeded to this mix, and not areas seeded to "Mixture Special Mix." *Setaria glauca* dominates.

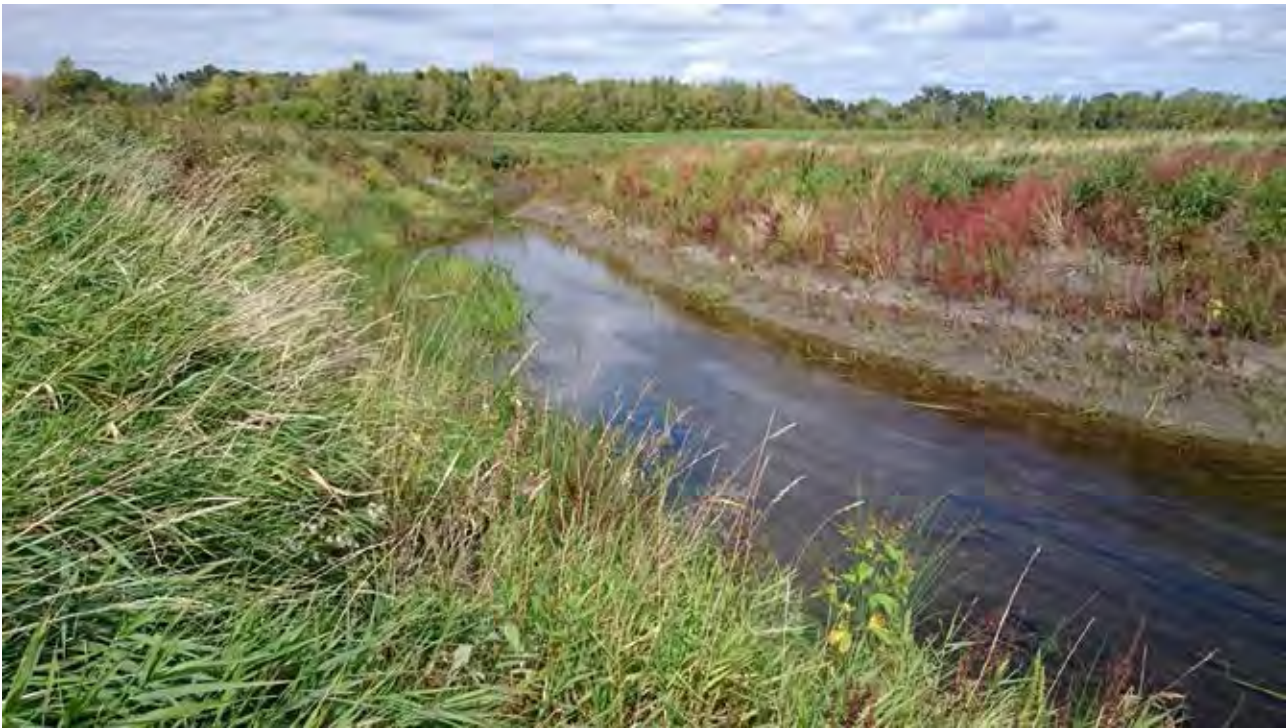
SR Photo 20: Restored Channel north of 130th Street NW. Above the channel, Seed Mix MnDOT 250 was used. Uplands largely dominated by Smooth Brome with Reed Canary grass common near/in channel.

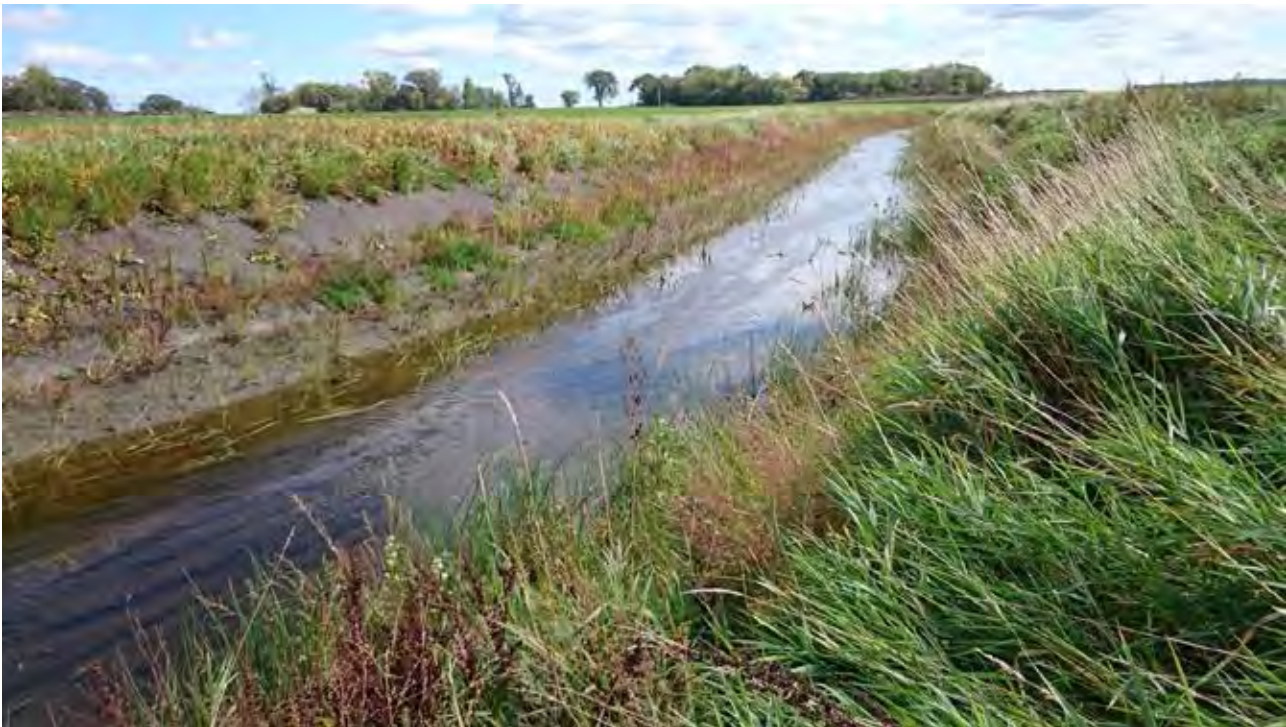
SR Photo 21: Dense Smooth Brome above channel with bare soils below.
