Lessard-Sams Outdoor Heritage Council

Laws of Minnesota 2014 Accomplishment Plan

Program or Project Title: Restoration Evaluations

Technical Panel Findings and Recommendations—Fiscal Year 2015

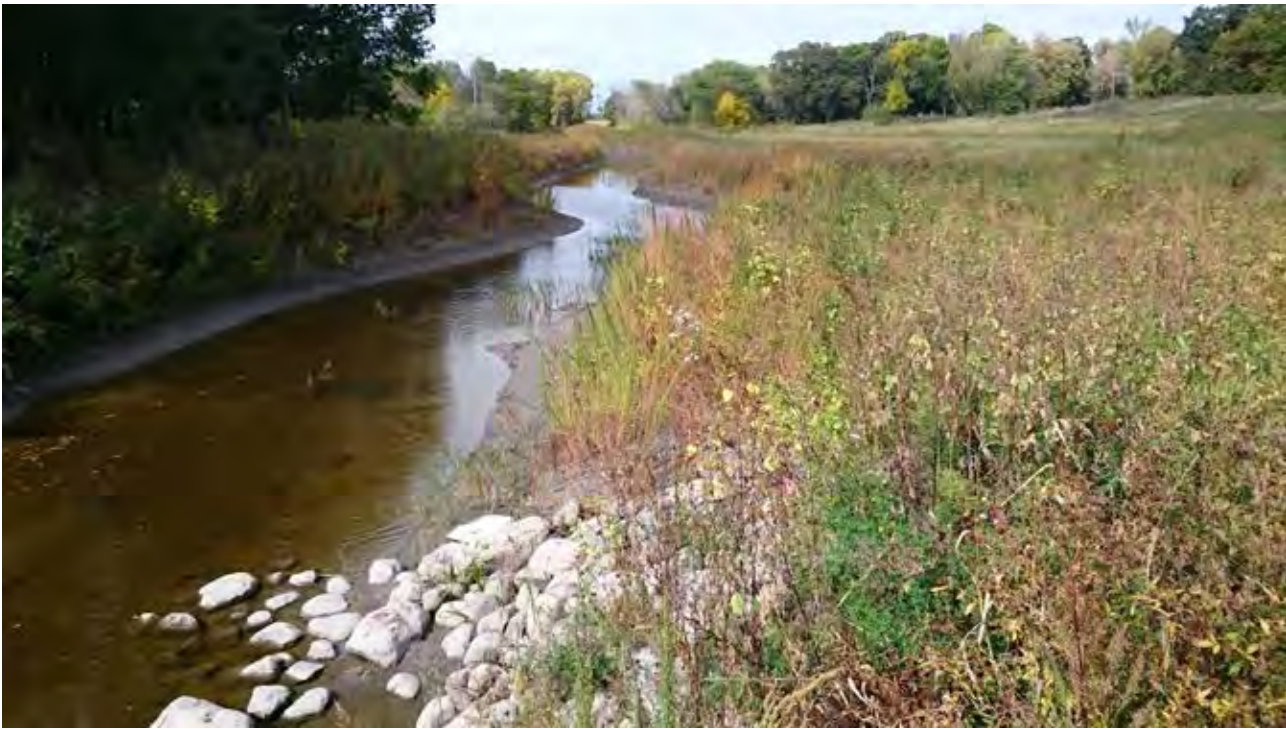
SR Photo 23: Riffle Boulder Vane below railroad car bridge.

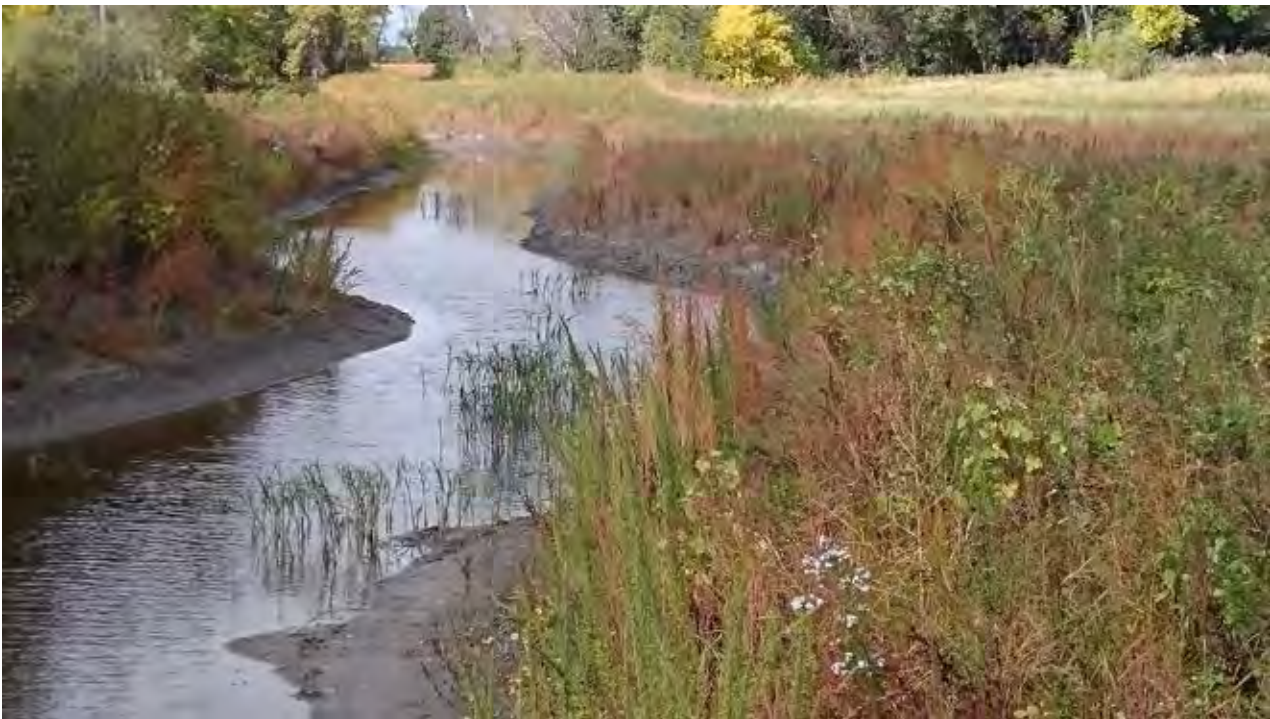
SR Photo 24: Vegetating slopes dominated by annual forbs.

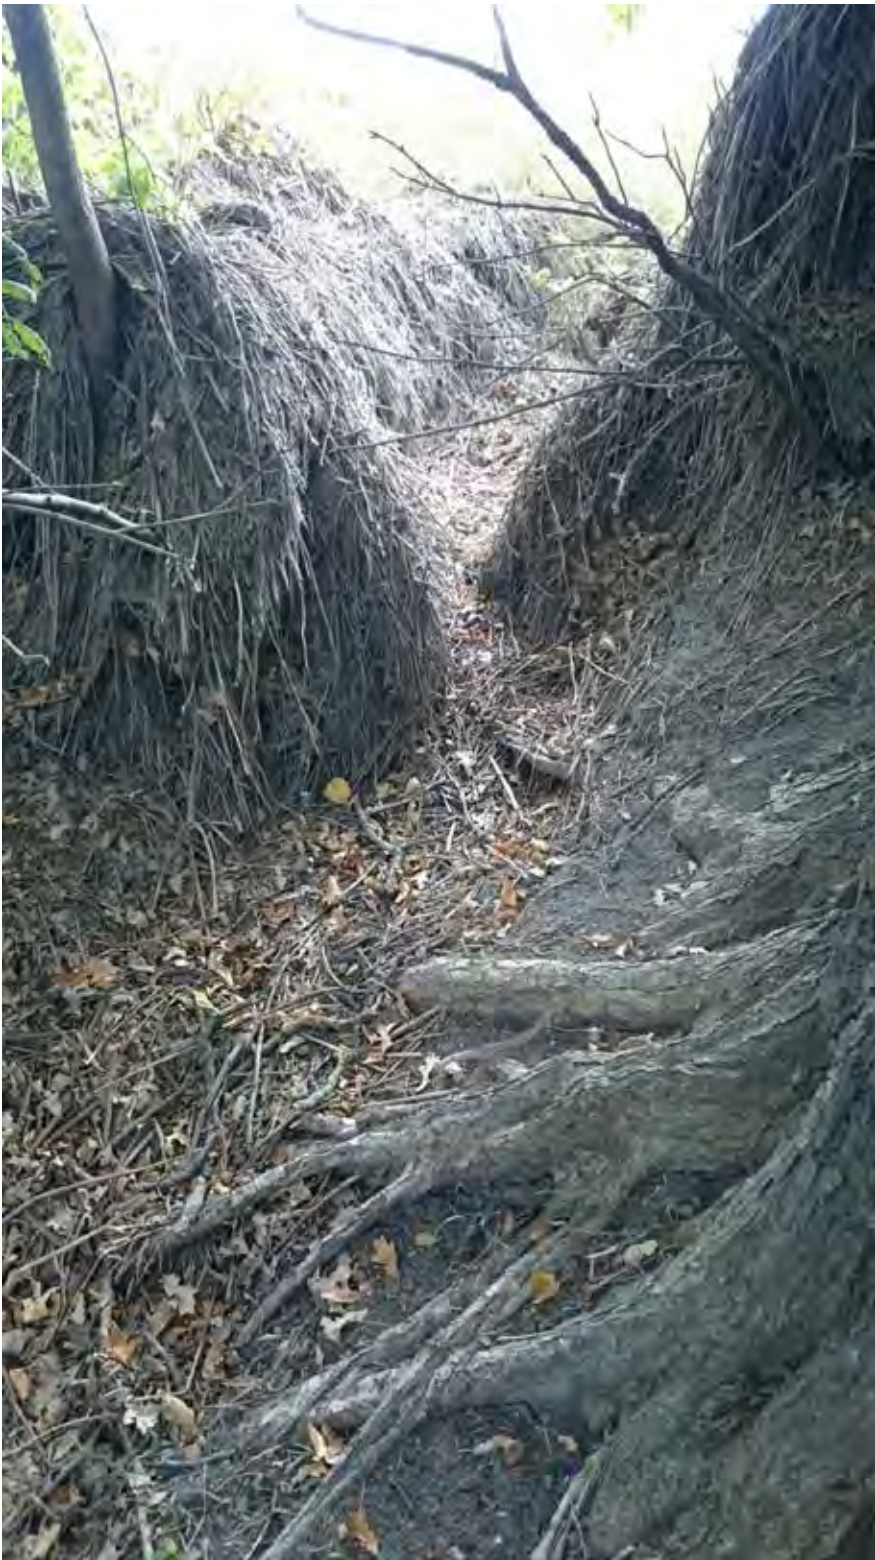
SR Photo 28: Gully above construction area in wooded area. Likely predates project as it is above existing exposed roots.

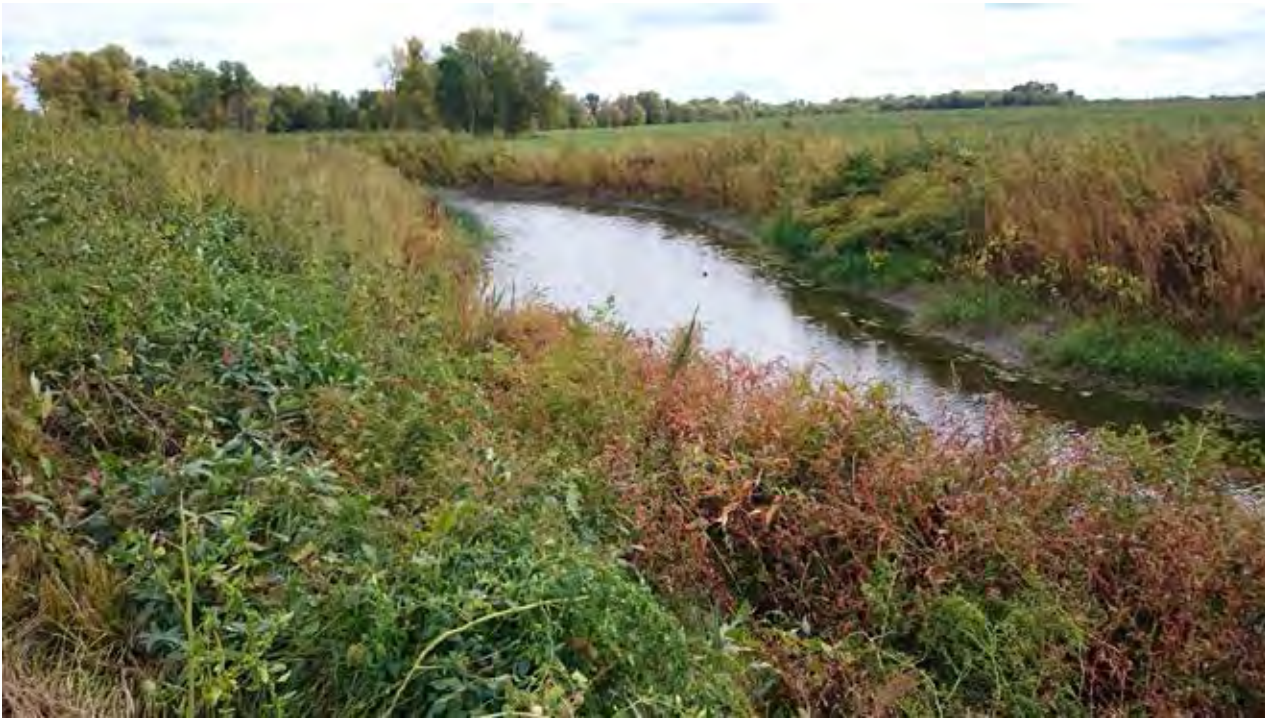
SR Photo 31: Heavily vegetated banks in the openings below cleared woods. Annuals dominate.

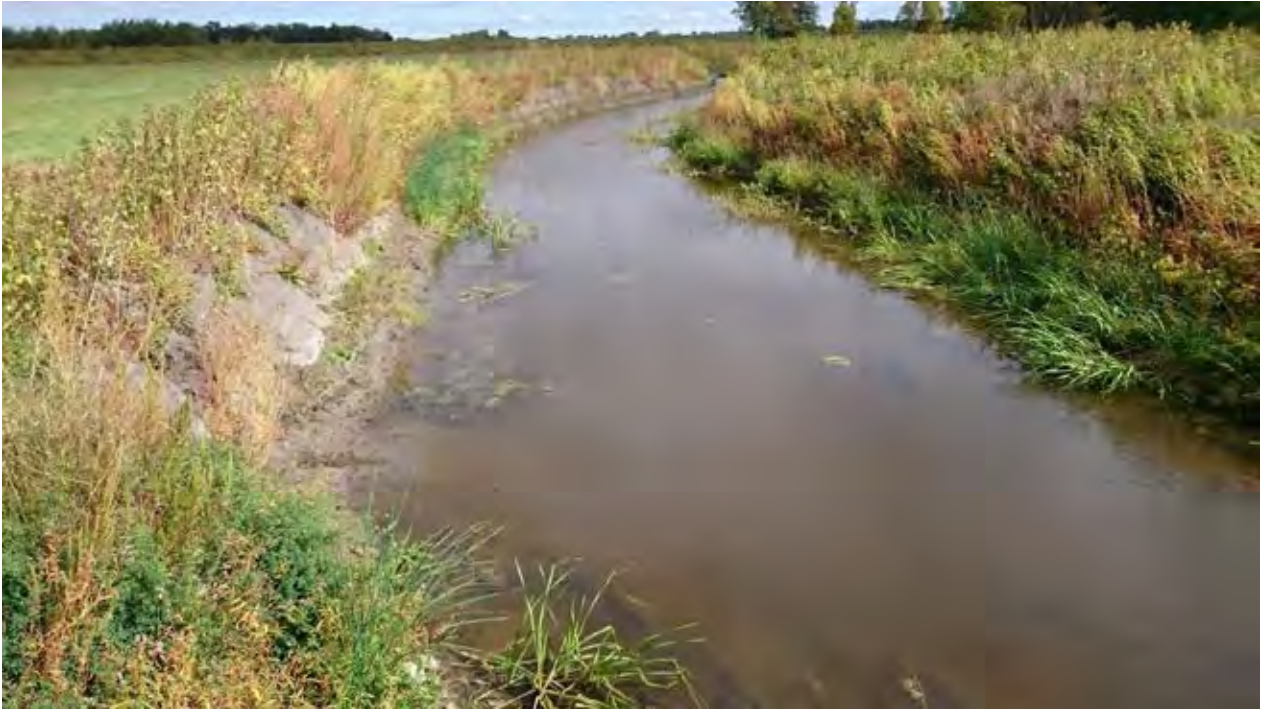
SR Photo 32: Exposed banks along slopes downstream of cleared woods.

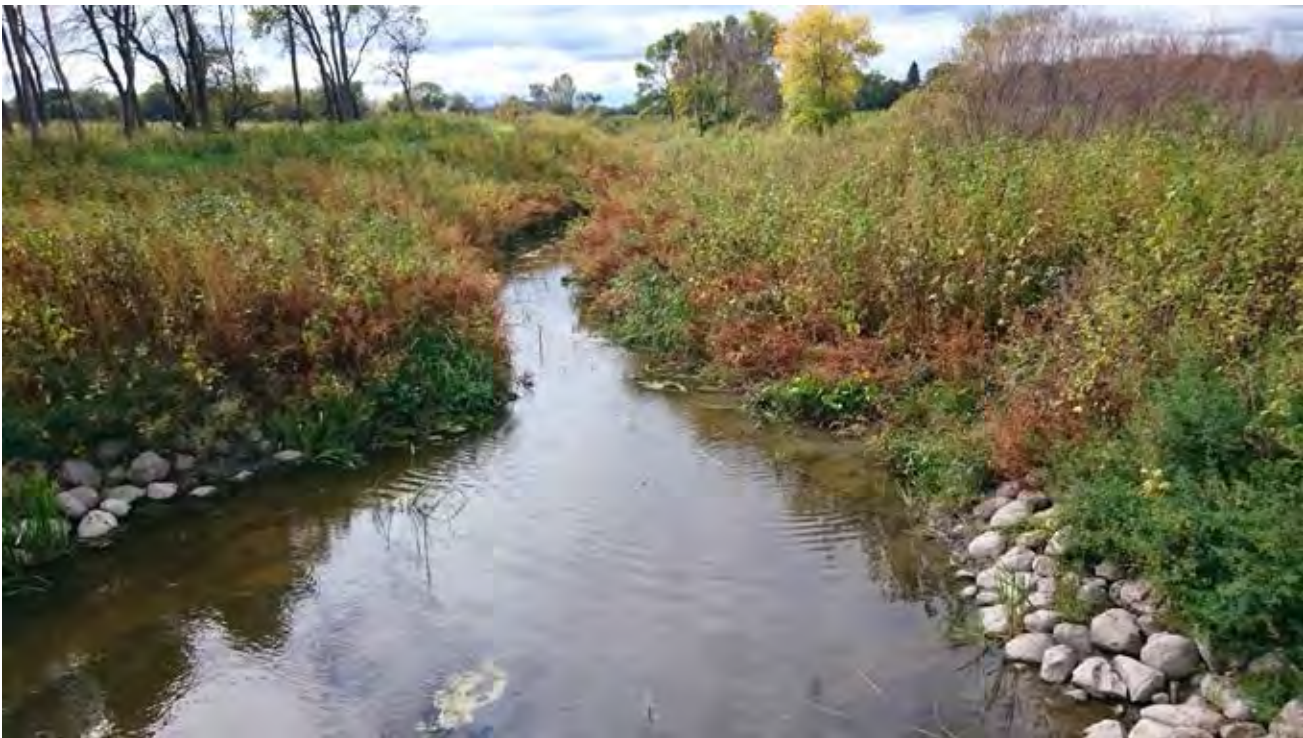
SR Photo 33: Rocked channel border above Boulder Vane.

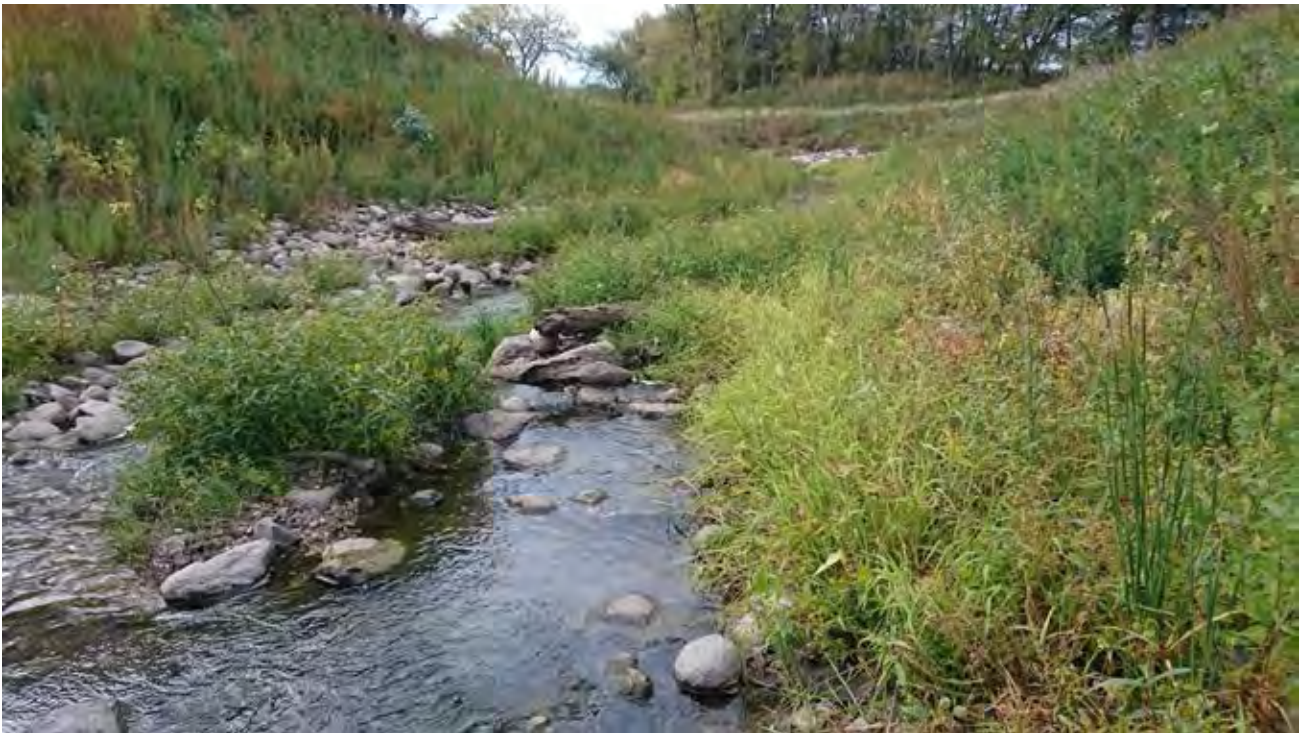
SR Photo 34: Entering the V Channel Riffle at downstream portion of project.

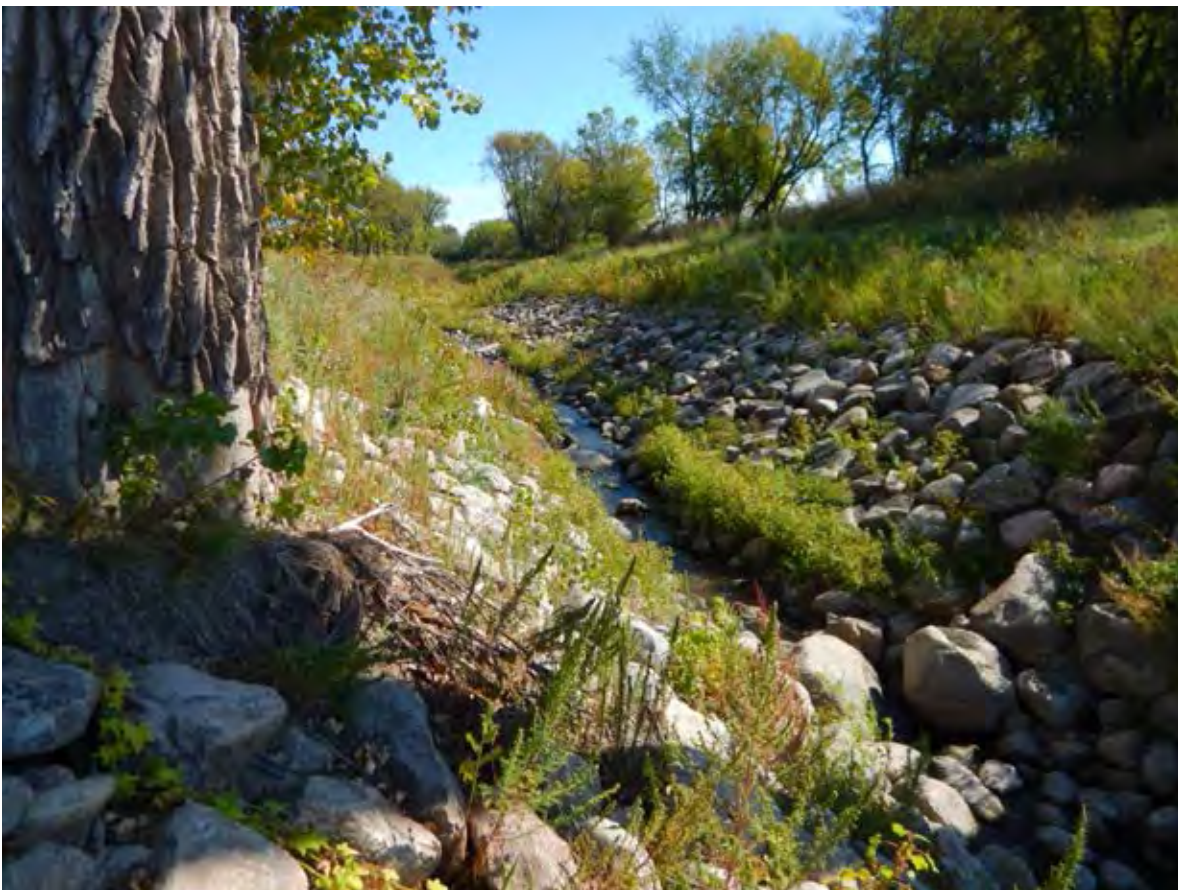
SR Photo 36: V Channel immediately upstream of confluence with the Red River.
Note scour at base of cottonwood tree at top of slope.
