BY CRAIG WILSON

THE REHABILITATION OF A RIVER

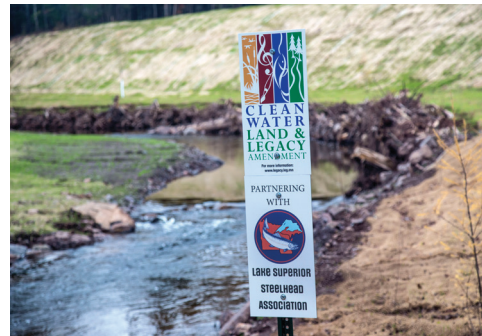
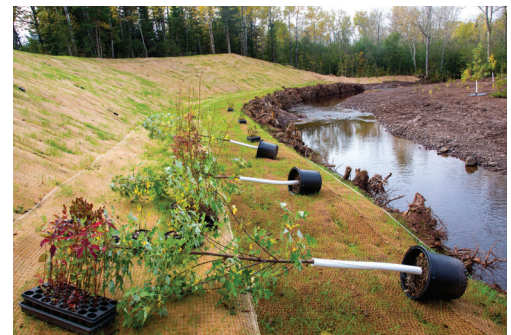
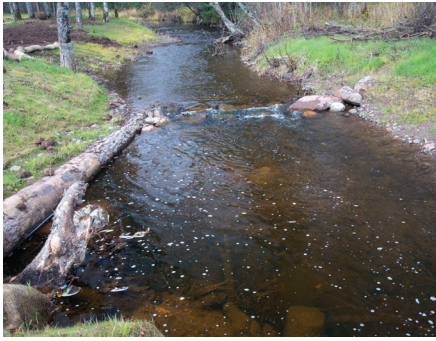
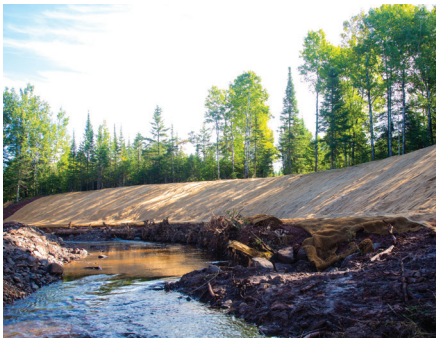
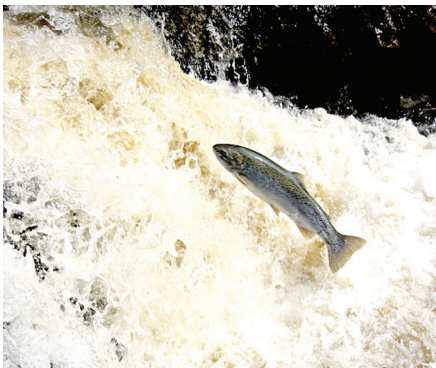
THE USE OF THESE NATURAL MATERIALS NOT ONLY STABILIZES THE STREAM, BUT ALSO PROVIDES IMPORTANT SUBSTRATE FOR TROUT AND OTHER AQUATIC LIFE.

materials, such as tree trunks, root wads, brush bundles, boulders, coconut matting, straw bales, soil and seed as the raw construction materials. The use of these natural materials not only stabilizes the stream, but also provides important substrate for trout and other aquatic life.
