Lessard-Sams Outdoor Heritage Council

Laws of Minnesota 2014 Accomplishment Plan

Program or Project Title: Restoration Evaluations

Technical Panel Findings and Recommendations—Fiscal Year 2015

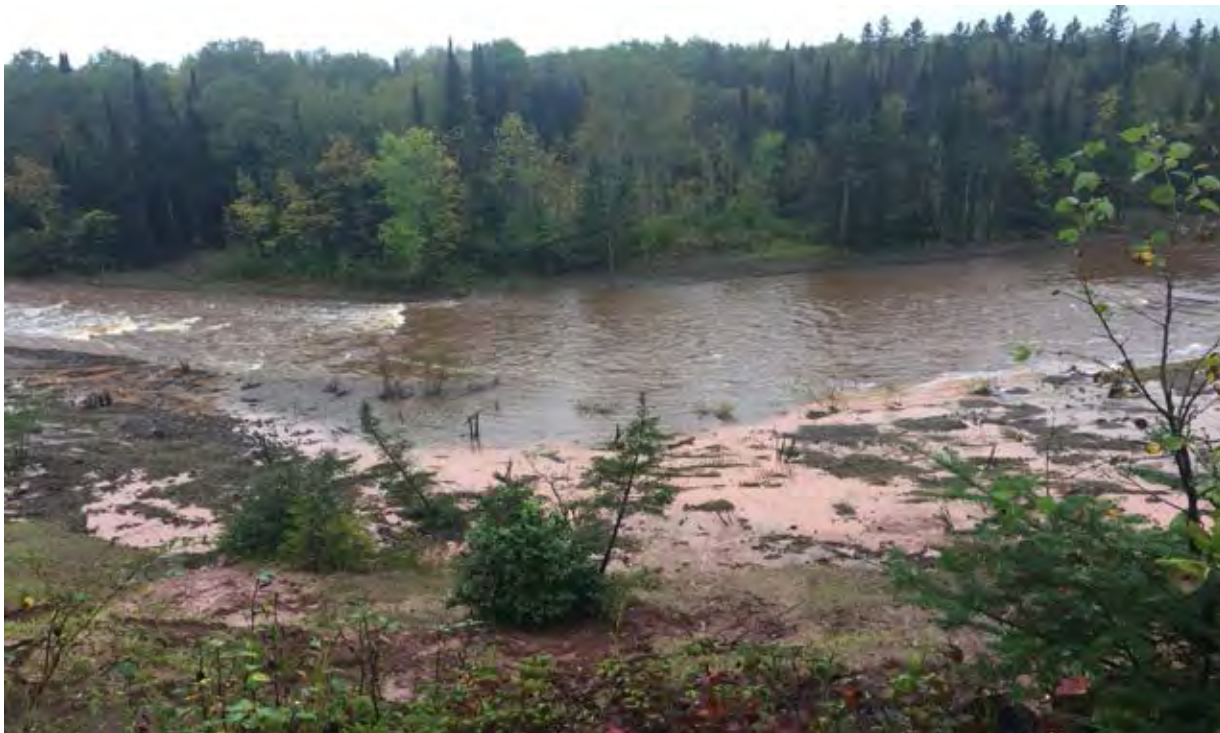
Figure 5 - Representative image of stabilization (bankfull bench). As illustrated in the photograph the created bankfull bench was appropriately being accessed (over-topped) by a near bankfull flow event.

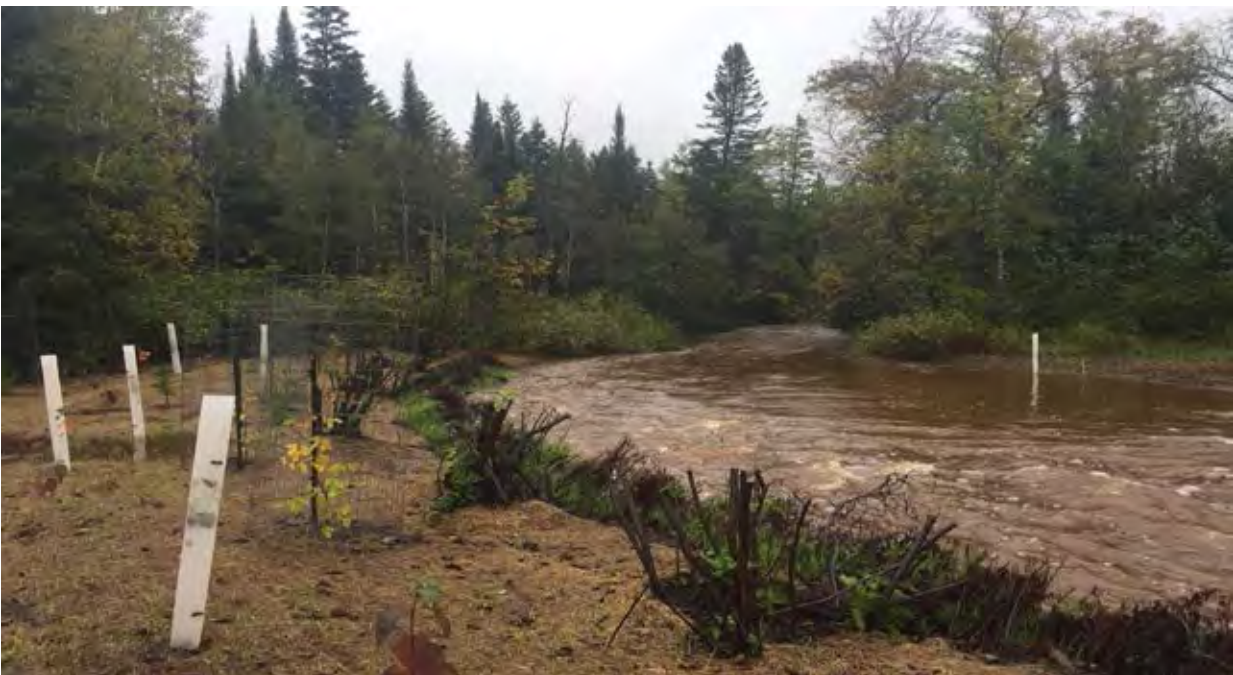
Figure 4 - Representative image of toe wood (near bank) and onsite transplants (near bank) along with the tree and shrub plantings with browse protection.

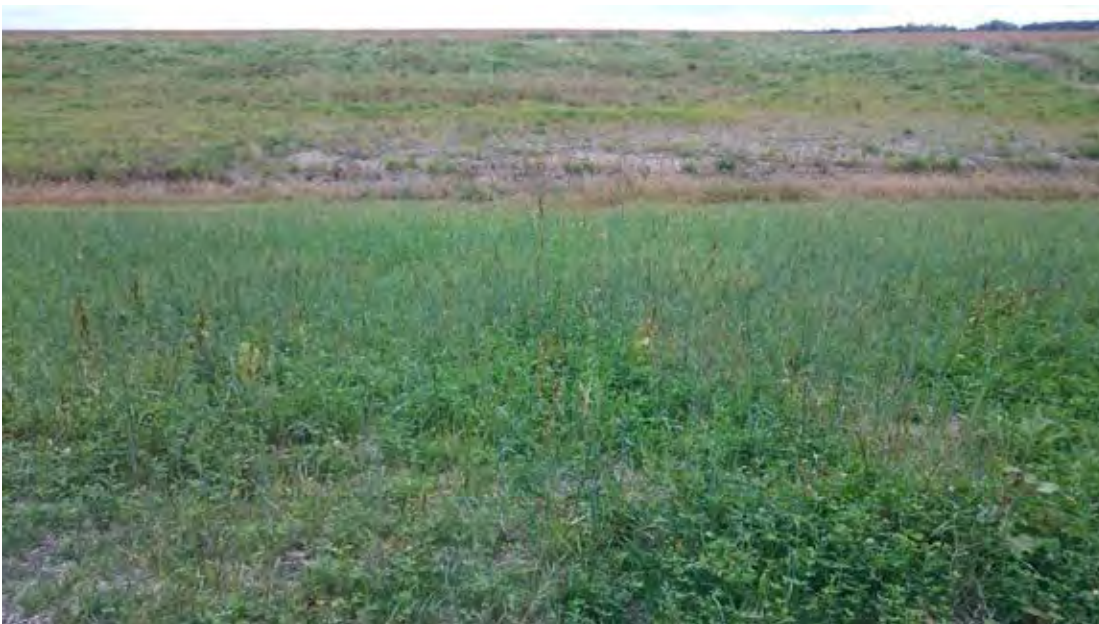
CC Photo 2: Stabilized slopes along upper channel. Note erosion at lower elevations near water level.

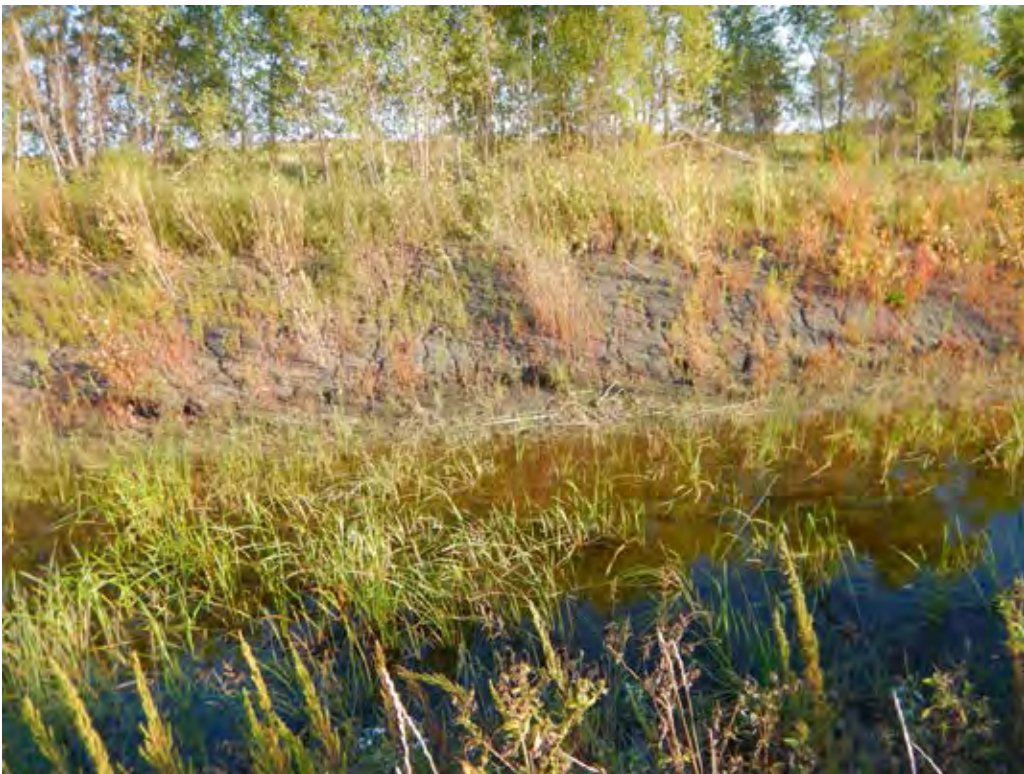
SR Photo 13: Unseeded slope at excavated channel.

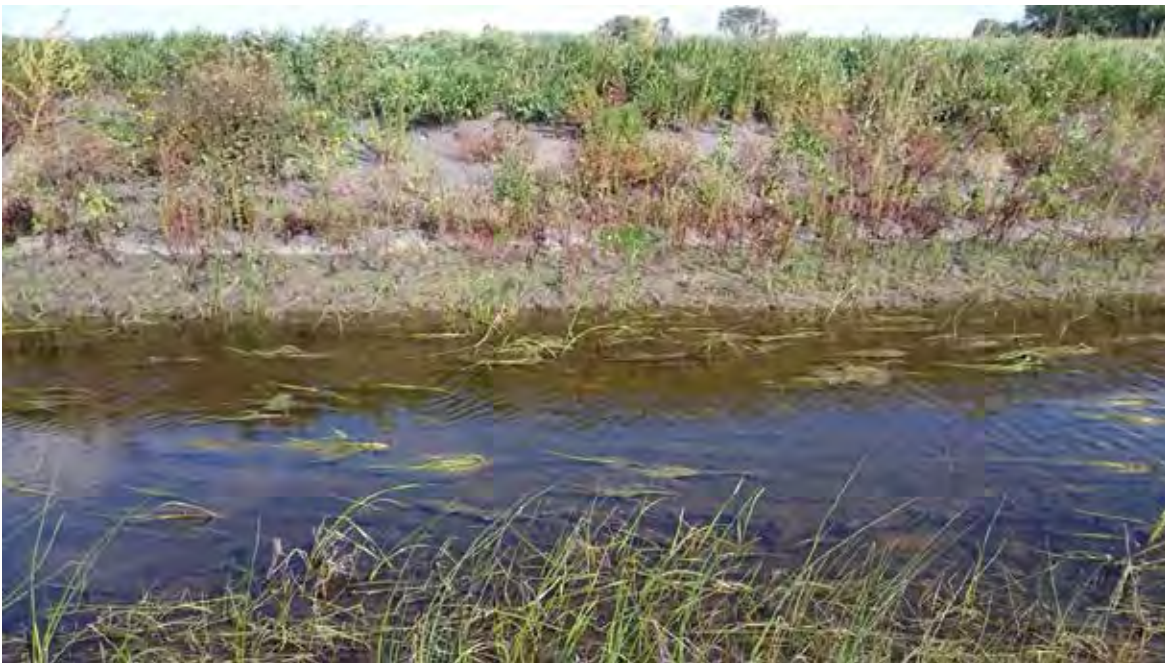
SR Photo 15: Bare slopes where unseeded.

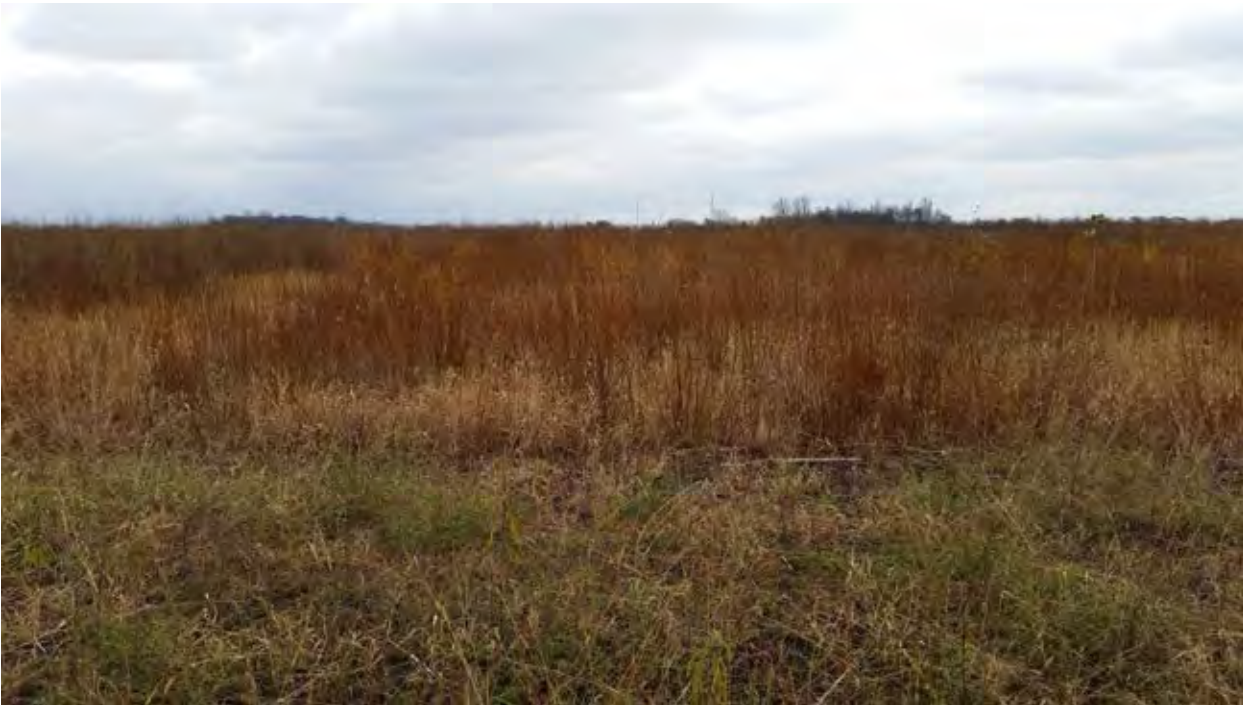
Figure 12 - Scrape at Basin #9, GPS 516
