MEMO: Agenda Item #6
DATE: June 23, 2015
SUBJECT: Fiscal year 14 report on Restoration Evaluations
PRESENTER: Wade Johnson, Restoration Evaluations Coordinator, DNR

Legacy Fund Restoration Evaluations, Fiscal Year 2014

Date of Report: April 30, 2015

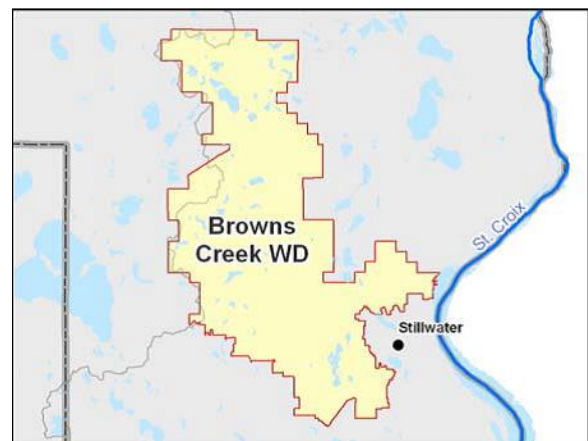
This project significantly improved stream habitat and restored a functional riparian zone to a highly degraded 1300 foot reach of Brown's Creek. This site posed significant challenges to achieving an effective stream restoration; most notably being bounded by an active golf course. The project designers worked closely with the golf course operators to develop a plan that enabled continued golfing and maximized ecological benefits. The designer's chose to not manipulate the cross section of the stream. This provides a learning opportunity for a passive approach to stream restoration. One year post installation the riparian planting was well established. The stream was responding to the stable buffer plantings by deepening and narrowing the channel. These changes will be beneficial, both for fish habitat and for water temperatures important in a trout stream.

4. Site description (by reviewer): Brown's Creek flows through Oak Glen Golf Course at the project site. The initial condition of the riparian zone had turf grass mowed up to the water's edge, resulting in eroding stream banks. Over time this condition has allowed the stream to widen to the point where water depths were very shallow. Bottom substrate was almost uniformly sand and silt, with very little cover for fish. The wide and shallow stream with no overhanging vegetation created a situation for signifcant warming of the water through this reach, affecting the suitability of this and downstream reaches for trout.

9. Are corrections or modifications needed to meet proposed outcomes? Explain.
 The modification of the previously constructed riffles under bridges may further benefit the stream, but the return on investment of undertaking such a modification is questionable given the costs of mobilizing a contractor, working with the golf course to find a time for heavy equipment work that does not conflict with course operation, and the temporary sediment suspension impacts of disturbing the stream channel. I would recommend leaving the project as-is and evaluating the results. Vegetation establishment has been successful at the site. It will be important that reed canary treatment continue to ensure that it does not spread.

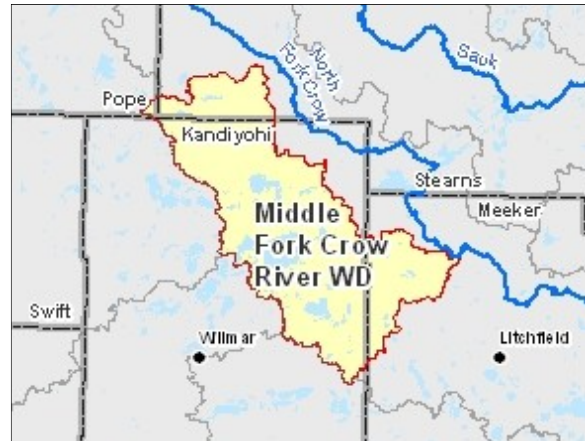
Four lakeshore restoration projects on three lakes were assessed for this evaluation. All four projects stabilized existing erosion along shorelines. One project on Lake Monongalia stabilized and vegetated 320 linear feet of highly eroded shoreline utilizing multiple bioengineering techniques. These included cedar revetments anchored to the foreshore, biologs staked to the toe, vegetated soil lifts (soil/compost wrapped in degradable blankets), live stakes, brush bundles and geogrid rock wraps in the highest wave energy areas. This site also stabilized the adjacent slope of mature oak forest with coir blanket and native plant plugs. This upslope stabilization extended an average of 40 feet inland of the shoreline. This buffer intercepted and slowed runoff that previously eroded the steep slope. The Lake Monongalia site utilized an appropriate combination of best practices for bioengineered stabilization and functional native plant use. This project benefited from design assistance from the West Central Technical Service Area staff and installation by an experienced restoration contractor.

For three of the projects the Clean Water funds were used for plantings above reinforced riprap. Due to walls at the top of slope and upland topography these three stabilization plantings did not intercept upland runoff from above the planted slope. Retaining walls are no longer accepted by the watershed district in conjunction with shoreline restoration projects, as they increase hard structure, replace the stabilizing and habitat improving capacity of native perennials and shorten the inland depth of the buffer. All three projects showed reasonable establishment of seeded and planted species one year post planting. One site showed greater than 40% cover of invasive grasses and forbs. Targeted invasives control will be needed to attain the planned native planting. These projects provide improved

conditions and potentially support shifting cultural practices towards naturalized shorelines. However, the Panel believed these three projects may have limited benefit for water quality and shoreline habitat. Based on the specified project goals and the early stages of the restorations, these projects were rated as minimally meeting or meeting proposed outcomes. The Panel supports project managers recruiting and pursuing only projects that have best capacity to directly achieve broader restoration goals with these valuable public funds (see Improved Design Criteria p. 14).

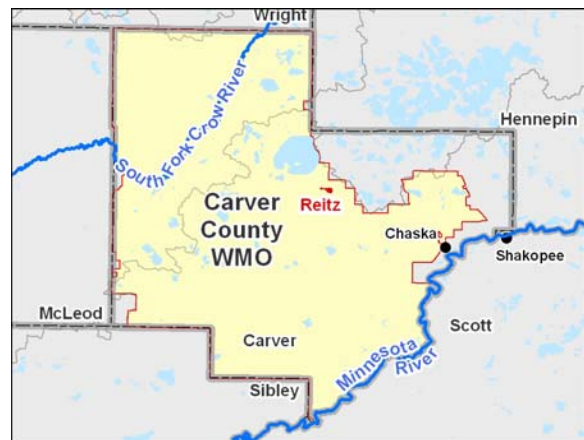
participate in shoreline restoration activities. All of the properties were experiencing some degree of shoreline erosion from upland runoff and/or wave action. This has been exacerbated in recent years by fluctuating lake levels. All four shorelines were installed per contractor's plans approved by the conservation district. Sites were prepared by cutting, burning or herbiciding existing undesired vegetation. Native perennial species were planted per plan.

Two projects (Reitz Lake 2 & 4 evaluations) replaced existing turf grass at the shoreline with native garden beds. These projects applied appropriate site preparation of two herbicide applications. An appropriate diversity of native plants plugs were planted. Plant establishment has progressed acceptably and plant beds have been appropriately weeded and maintained with guidance from SWCD staff. One project installed biologs at the shoreline to prevent further shoreline erosion. The other did not secure the shoreline and has experienced approximately one foot of further shoreline loss since the project was installed. This is primarily attributed to significant fluctuations in lake level during that time. It appears that the "raingarden" integrated into the native garden may also have exacerbating shoreline erosion due to the shallow seep of water emerging at the eroding shoreline. This project also installed a patio between the native gardens that may offset some of the project's restoration benefits as well (patio installation did not utilize clean water funds). These projects utilized 50-75% of the properties shoreline width and extended 10-15 feet inland from the shore. The Panel felt that practices such as these should be encouraged for private shoreline owners as alternatives to turf grass. However at this scale they provide minimal contribution to water quality and should be considered lower priority for investment of public Clean Water funds.

One project (Reitz Lake 3 evaluation) site stabilized a ravine and replaced turf with natives above existing riprap. This project captures runoff from greater than 4+ acres during heavy rain events. This stormwater flow is concentrated through a ravine on the property that formerly intensified shoreline erosion problems. This project is well sited for upland runoff interception, utilizing a series of vegetative and structural techniques (rock checks and raingarden) to slow down and soak up upland runoff to the extent possible. The scale of the project also provided significant benefit, extending more than 100 feet from the shoreline up the ravine. Some mature trees were cleared during site preparation; primarily Green Ash; to allow adequate space for remaining mature trees and increased sunlight for establishment of ground layer perennials. The Panel emphasized the value of retaining as many large trees as possible for the combined benefits of woody root stabilization and rainfall interception.

Another project (Reitz Lake 1 evaluation) cleared existing Reed Canary Grass and Sandbar Willows (herbicide and burning), stabilized the shoreline toe with biologs and planted native plugs. In 2013, one year post installation, biologs were secure and stabilized the shore. However, the planted area was 95% Reed Canary with scattered native plugs. Site preparation for invasive Reed Canary was inadequate and attempts to remove Sandbar Willow are considered unfavorable given their shoreline stabilizing capacity. The Panel considered the upland planting portion of this site to not be an improvement over previous conditions, given the setback of willows and persistent dominance of Reed Canary. Project managers have taken steps to work with the absentee property owner to maintain the project per

- Project managers applied a logical prioritization for addressing water quality stressors in the Reitz Lake watershed: 1) Intercept agricultural runoff; iron enhanced sediment basin, engineered wetland nutrient capture above the inlet channel 2) naturalize upland shorelands to the extent practicable. Three of the four shoreline practices installed have the capacity to provide some water quality and habitat restoration benefits.
- Project effectiveness (water quality and habitat) could have been improved by application of improved screening and minimum design criteria (See Recommendation for Improved Design Criteria pg 14)
