Lessard-Sams Outdoor Heritage Council

Laws of Minnesota 2014 Accomplishment Plan

Program or Project Title: Restoration Evaluations

Technical Panel Findings and Recommendations—Fiscal Year 2015

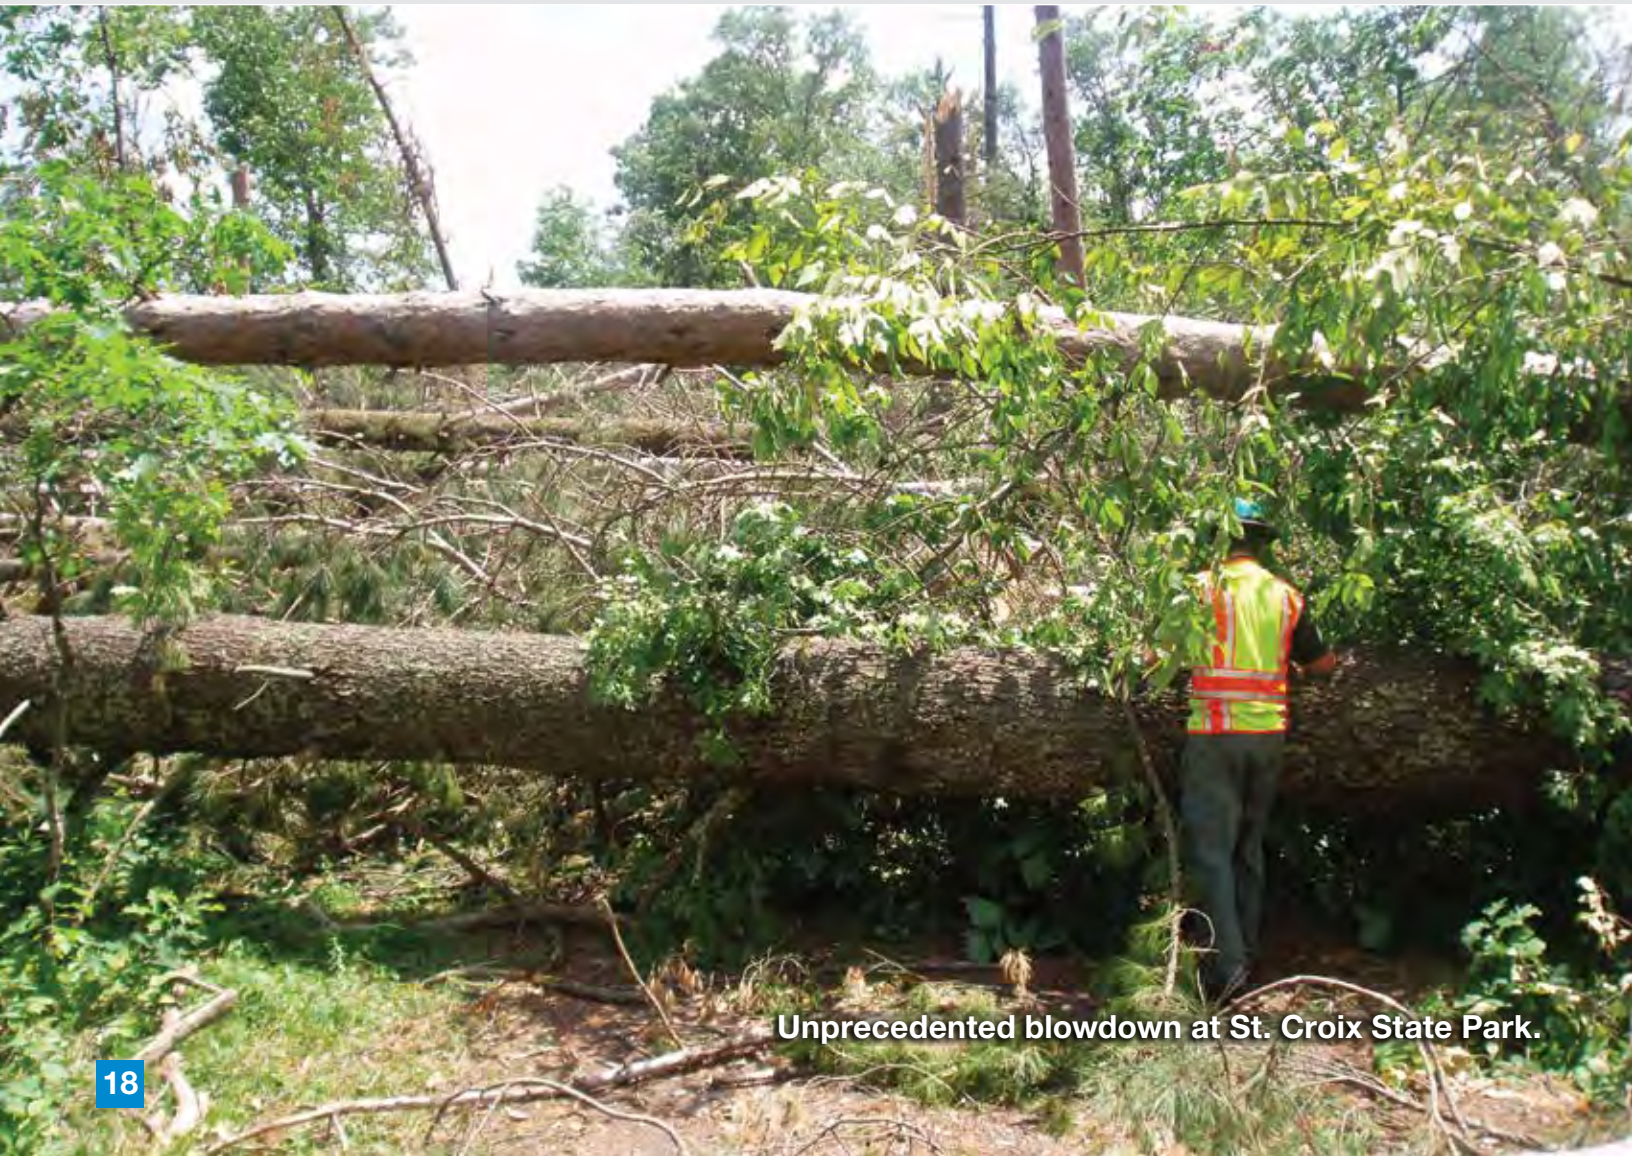
Unprecedented blowdown at St. Croix State Park.

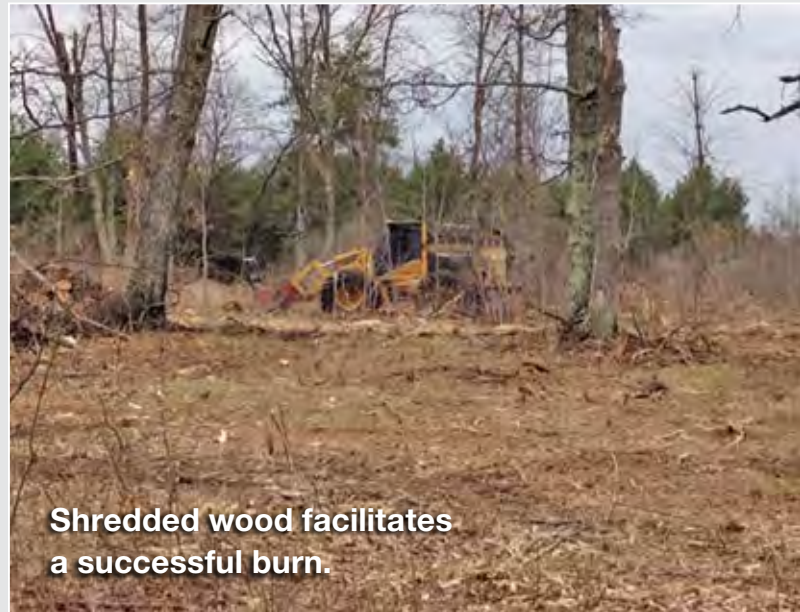
Shredded wood facilitates a successful burn.

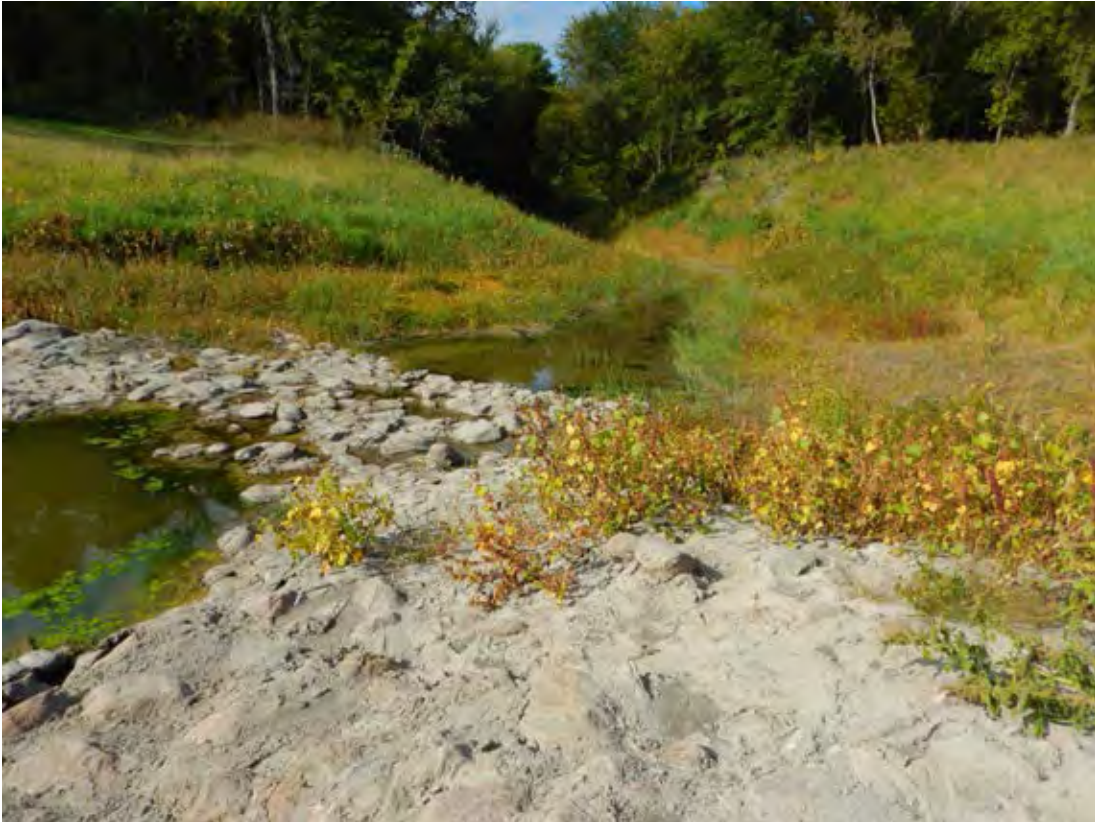
CC Photo 5: Immediately downstream of upper grade control structure.

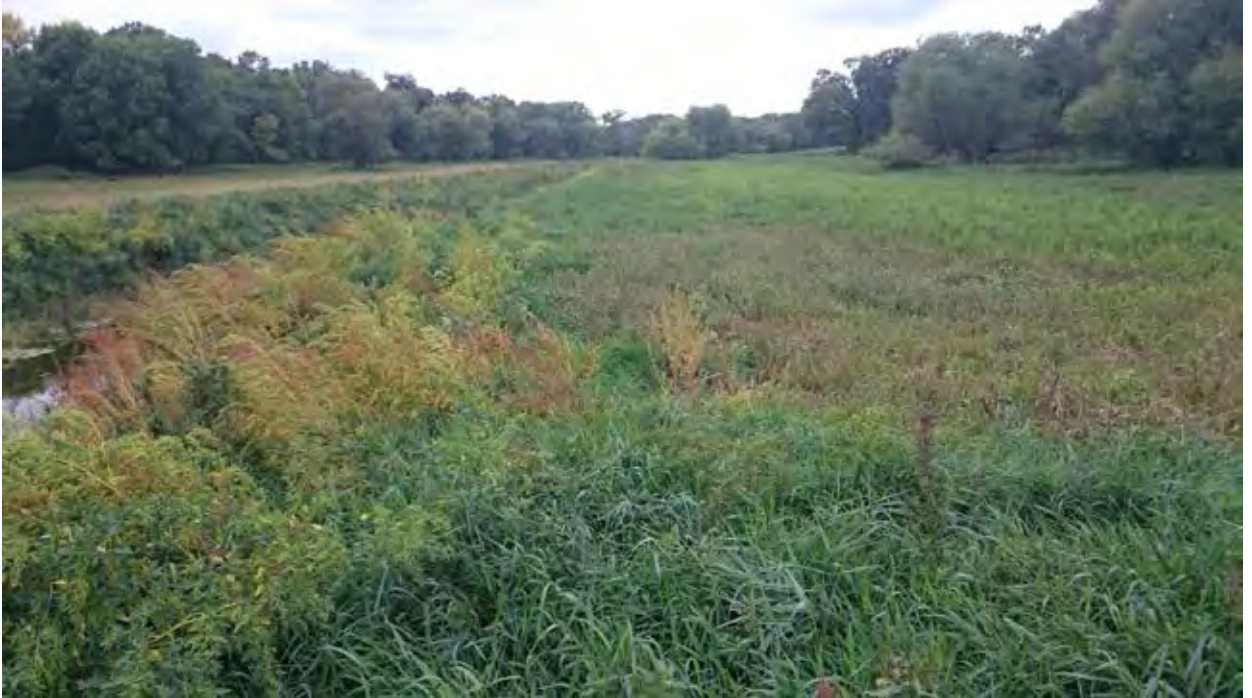
SR Photo 5: West bank immediately downstream of Diversion Structure.

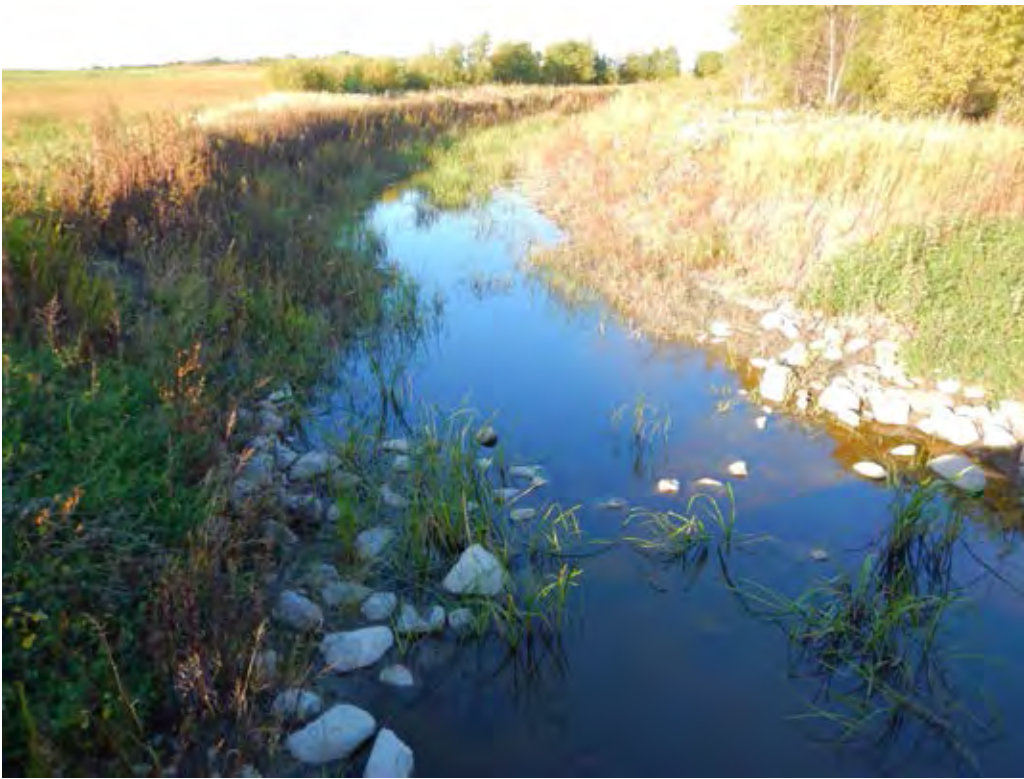
SR Photo 12: Ellipse Channel Riffle at 171+25. Vegetation is volunteer.

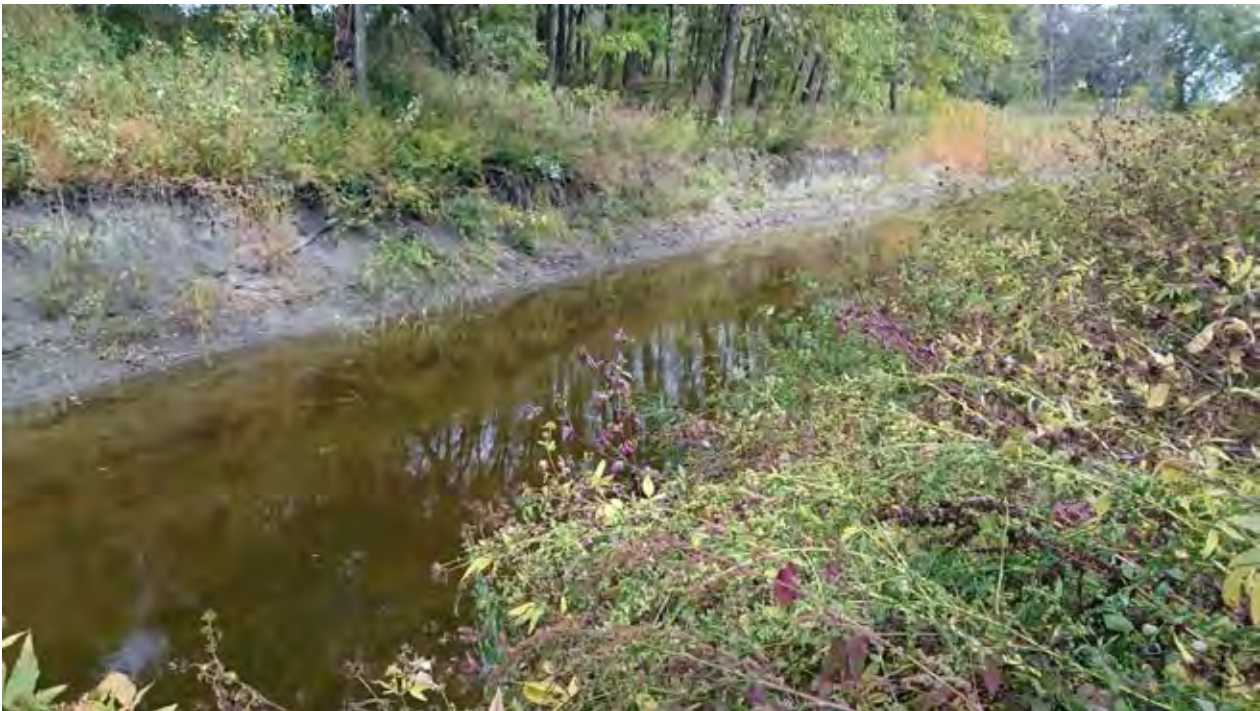
SR Photo 25: Exposed banks where channel was excavated in forested areas.

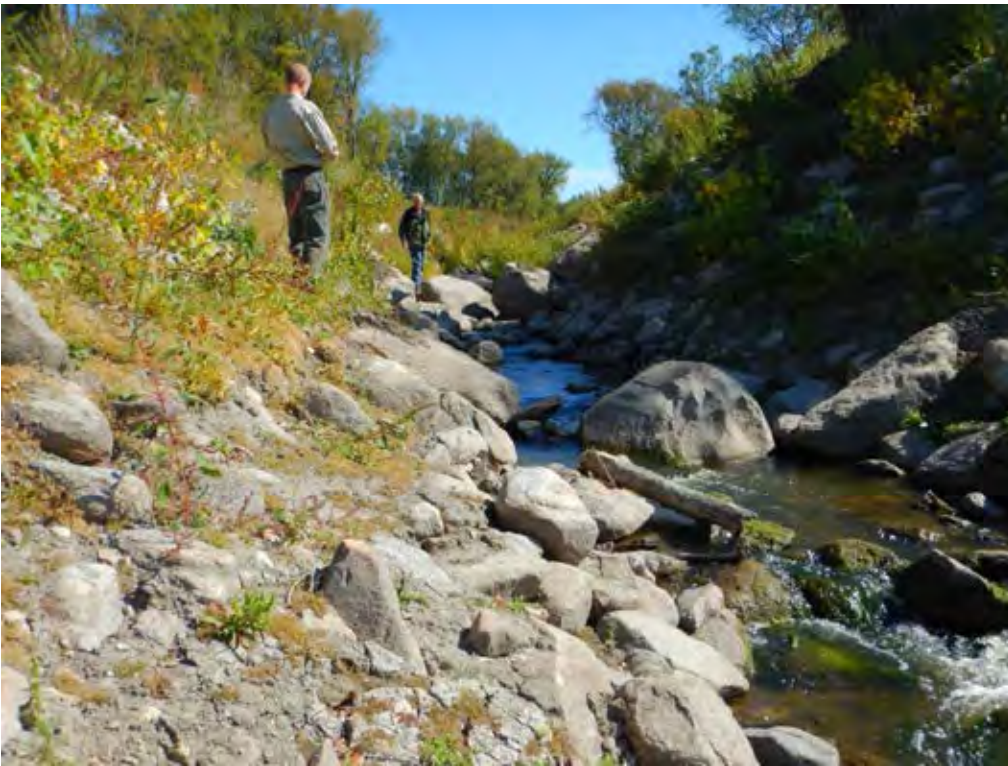
SR Photo 37: V Channel at outlet to Red River.

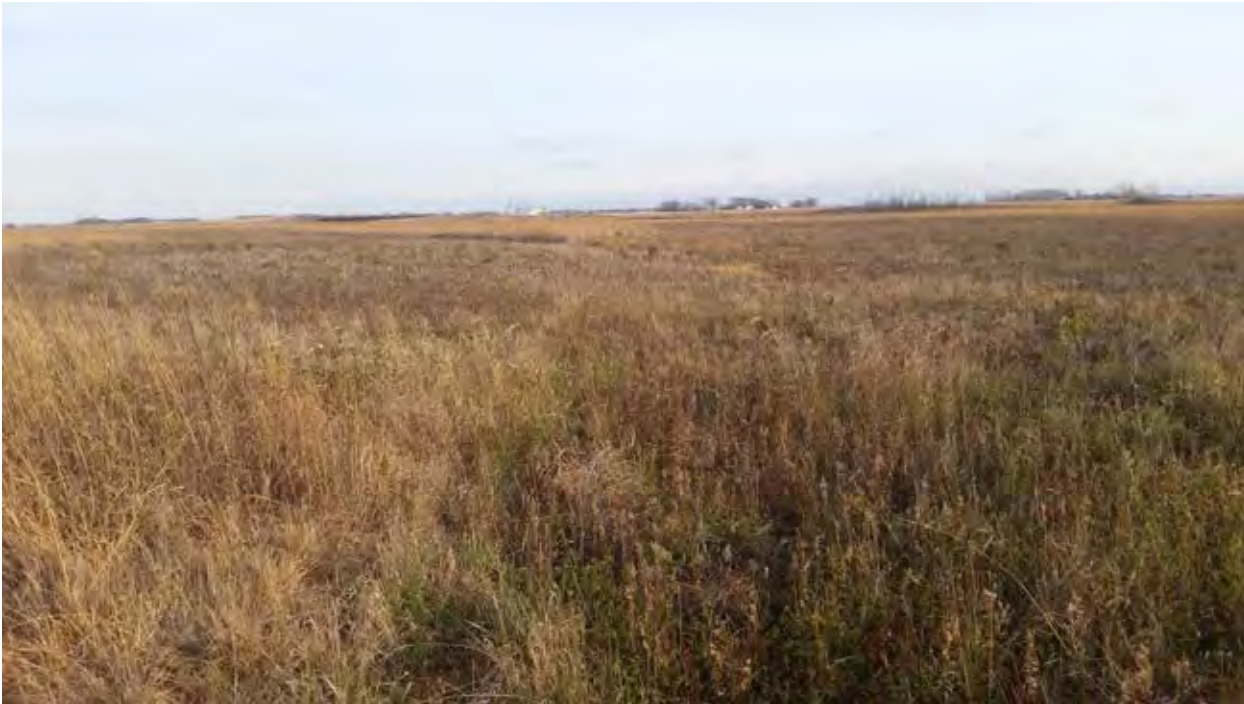
Figure 6 - Cattail and wetland buffer mowing at GPS 507, Basin 2.

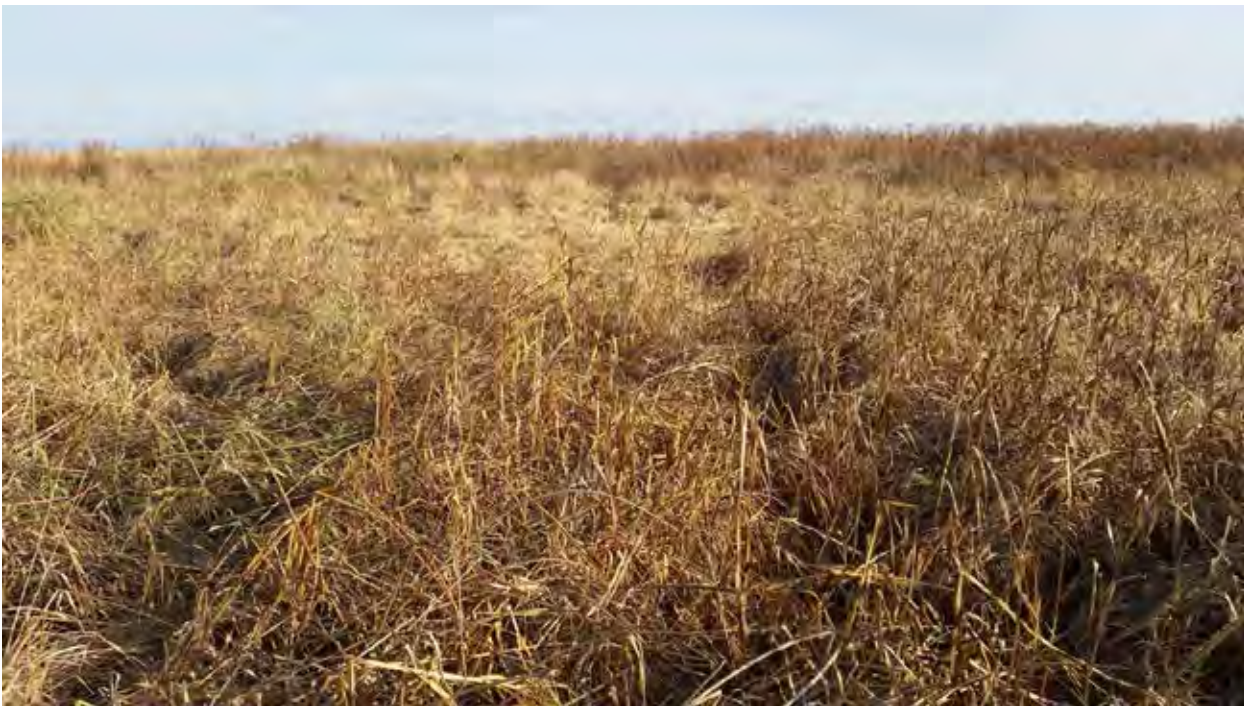
Figure 7 - River Bulrush at GPS 509, Basin 3.

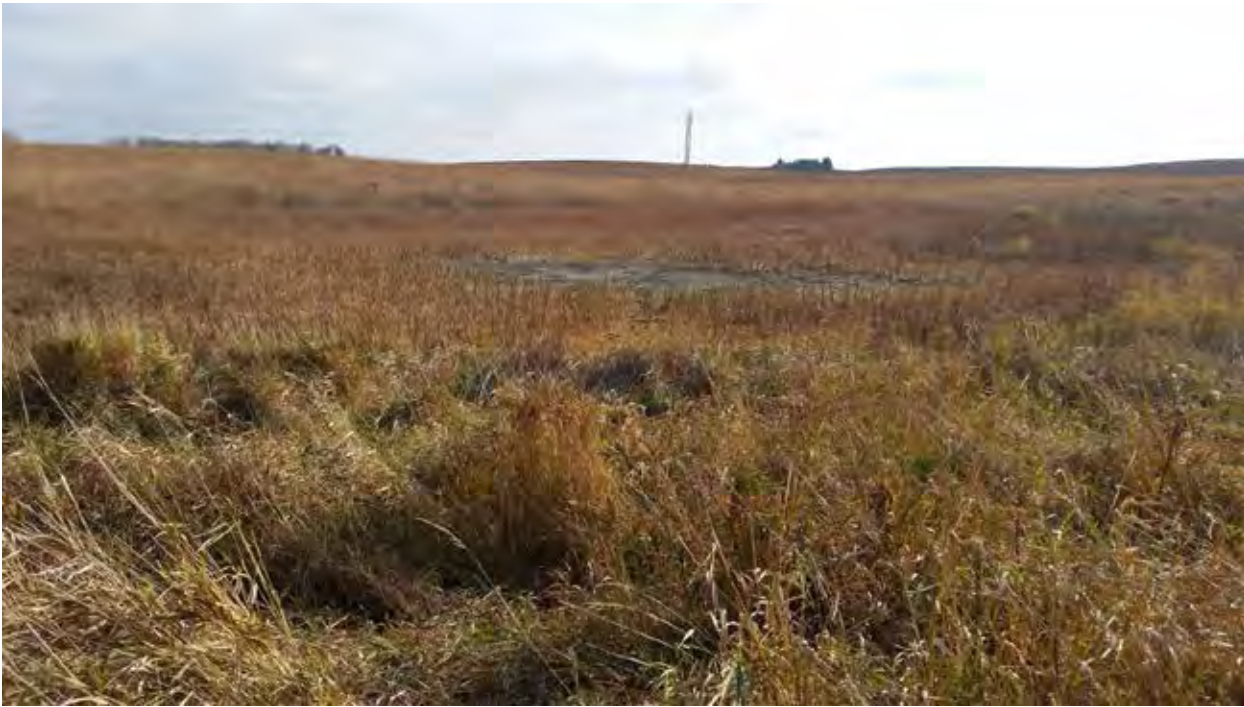
Figure 7 - Basin #1 at GPS 511

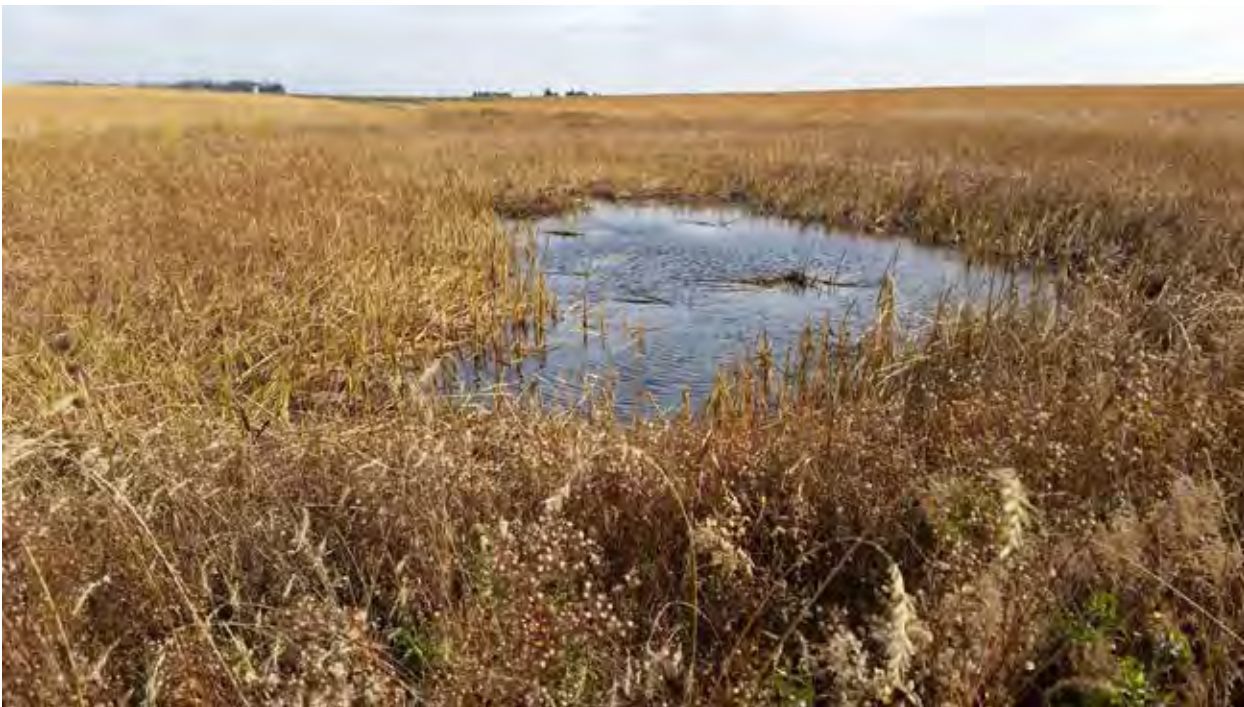
Figure 8 - Basin #3 at GPS 513

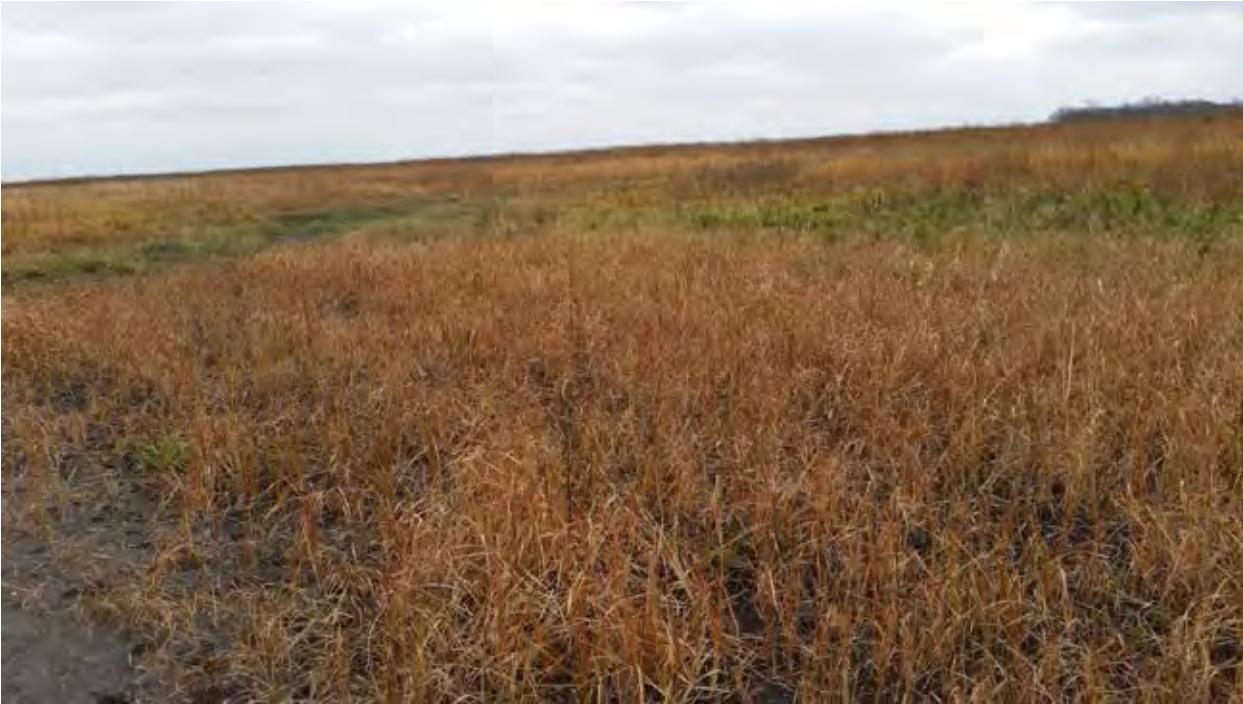
Figure 11 Basin #12 at GPS 517
